## Access Compliance Report Public Rights-of-Way (Curb Ramps)

Intersection ID: 43681Main Street: WALKER\_RDCross Street: TODDINGTON\_LNLocation:NWADA ID: B3EFCA8973C9Ramp Type: PerpDiagInitial Pass/Fail: FailOverall Compliance: NoSeverity Score:10

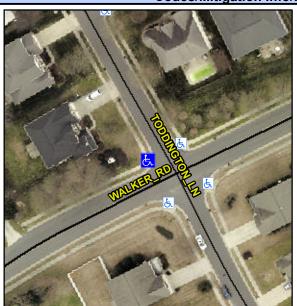
Not Found, R304.5.1, R304.5.3

Field Measurei	nents/C	ompo	nent Compliance	
Co	Compliance Description		Comp	liance Description	Data
N/A	A Ramp Length (in)	49.0	Yes	Ramp Slope (%)	7.1
No	Ramp Width (in)	40.0	No	Ramp XSlope (%)	4.1
N/A	A Flare Type LT	N/A	N/A	Flare Type RT	N/A
N/A	A Flare Slope LT (%)	N/A	N/A	Flare Slope RT (%)	N/A
N/A	A Flare Traversable LT?	N/A	N/A	Flare Traversable RT?	N/A
N/A	A Landing Length (in)	N/A	N/A	DWS Provided?	N/A
N/A	A Landing Width (in)	N/A	N/A	DWS Contrast?	N/A
N/A	A Landing Slope (%)	N/A	N/A	DWS Length (in)	N/A
N/A	A Landing X Slope (%)	N/A	N/A	DWS Full Width?	N/A
N/A	A Landing Curb? (Y/N)	N/A	N/A	DWS Offset (in)	N/A
N/A	A Shared Landing?	N/A			
N/A	A Gutter Ponding?	N/A	N/A	Gutter Slope (%)	N/A
N/A	A Gutter Lip Ht (in)	N/A	N/A	Gutter X Slope (%)	N/A
N/A	A Painted X Walk1?	No	N/A	Painted X Walk2?	No
	X Walk 1 Direction	To S		X Walk 2 Direction	То Е
N/A	X Walk 1 Width (in)	N/A	N/A	X Walk 2 Width (in)	N/A

X Walk 1 Slope (%)	2.8		X Walk 2 Slope (%)	0.5
	X Walk 1 X Slope (%)	0.6		X Walk 2 X Slope (%)	4.4
N/A	A Ramp inside XWalk1?	N/A	N/A	Ramp inside XWalk2?	N/A
	Road Slope (%)	1.5	N/A	Clear Space?	N/A
	Road X Slope (%)	3.9	N/A	Clear Space to XWalk (in)	N/A
N/A	Any Obstructions?	N/A	N/A	Storm Grate/Utility Hazard?	N/A
	Obstruction Type			Storm Grate/Utility Type	
		N/A			N/A
			Yes	Surface Condition? (G/P)	Good

Remove & Replace Curb Ramp With Two New Directional Ramps or Equivalent.
