# Access Compliance Report

## Public Rights-of-Way

| Intersection ID: 48494 | Main Street: MELFORT_WY | Cross Street: BEREWICK_COMMONS_PY | Location: NW |
| ADA ID: B3F093386F75 | Ramp Type: BlendTrans1 | Initial Pass/Fail: Fail | Overall Compliance: No |

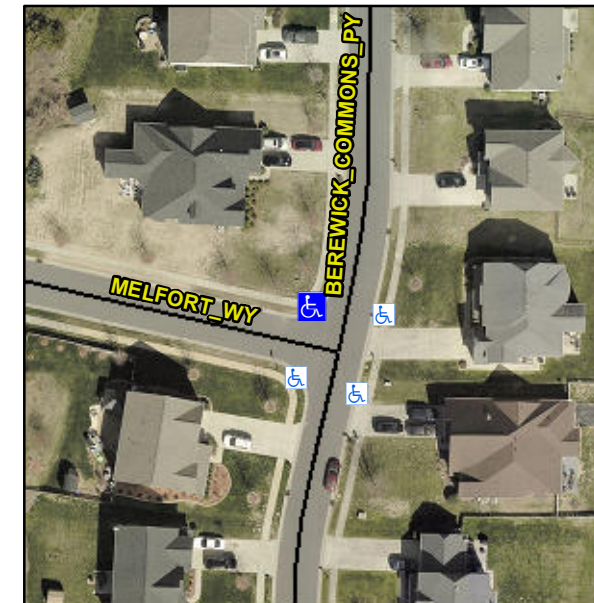
| | | Severity Score: 8.75 | |

**Not Found, R304.5.1**

| Compliance | Description | Data | Compliance | Description | Data |
|---|---|---|---|---|---|
| No | Ramp Width (in) | 43.5 | Yes | BlendTrans XSlope (%) | 1.3 |
| | | | No | Curb Slope (%) | 8.9 |

**Remove & Replace Curb Ramp With Two New Directional Ramps or Equivalent.**

Total Cost: \$ 3200.00
