# Access Compliance Report

## Public Rights-of-Way

| Intersection ID: 44109 | Main Street: TRAHERNE_CT | Cross Street: STAFFORDSHIRE_LN | Location: NE |
| ADA ID: B3F0D98928A4 | Ramp Type: Perp | Initial Pass/Fail: Fail | Overall Compliance: No |

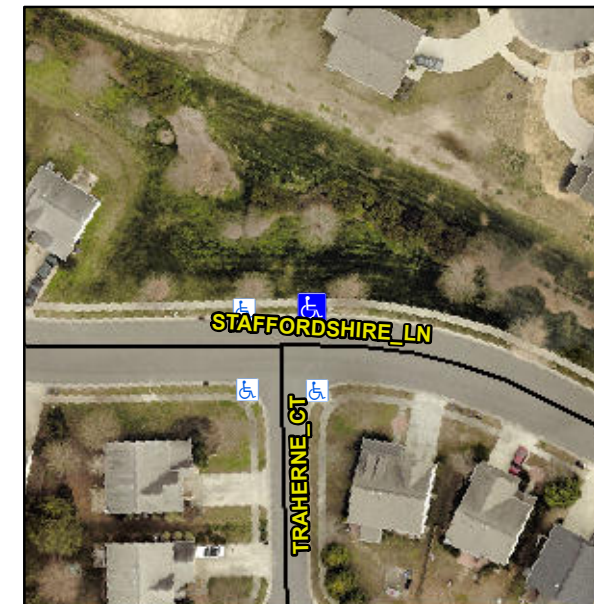
**Not Found, R304.2.2**

| Compliance | Description | Data | Compliance | Description | Data |
|---|---|---|---|---|---|
| N/A | Ramp Length (in) | 48.0 | No | Ramp Slope (%) | 11.8 |
| Yes | Ramp Width (in) | 48.0 | Yes | Ramp XSlope (%) | 3.7 |

**Remove & Replace Entire Ramp.**

Total Cost: \$ 1850.00
