Access Compliance Report

Public Rights-of-Way

(Curb Ramps)

Intersection ID: 3552	Main Street: BRIDLE RIDGE LN	Cross Street: BRIGSTOCK CT	Location: SE
ADA ID: B4136936CE3F	Ramp Type: Perp	Initial Pass/Fail: Fail	Overall Compliance: No
Severity Score: 25			
Codes/Mitigation Info/Possible Solution		Field Measurements/Component Compliance

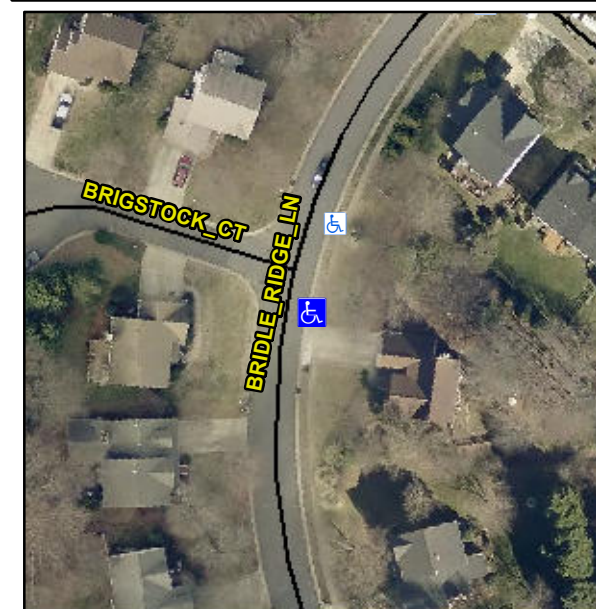
Not Found, R304.2.2

Compliance	Description	Data	Compliance	Description	Data
N/A	Ramp Length (in)	45.0	No	Ramp Slope (%)	14.7
Yes	Ramp Width (in)	48.0	Yes	Ramp XSlope (%)	1.0
N/A	Flare Type LT	N/A	N/A	Flare Type RT	N/A
N/A	Flare Slope LT (%)	N/A	N/A	Flare Slope RT (%)	N/A
N/A	Flare Traversable LT?	N/A	N/A	Flare Traversable RT?	N/A
N/A	Landing Length (in)	N/A	N/A	DWS Provided?	N/A
N/A	Landing Width (in)	N/A	N/A	DWS Contrast?	N/A
N/A	Landing Slope (%)	N/A	N/A	DWS Length (in)	N/A
N/A	Landing X Slope (%)	N/A	N/A	DWS Full Width?	N/A
N/A	Landing Curb? (Y/N)	N/A	N/A	DWS Offset (in)	N/A
N/A	Shared Landing?	N/A			
N/A	Gutter Ponding?	N/A	N/A	Gutter Slope (%)	N/A
N/A	Gutter Lip Ht (in)	N/A	N/A	Gutter X Slope (%)	N/A
N/A	Painted X Walk1?	No	N/A	Painted X Walk2?	N/A
	X Walk 1 Direction	To W		X Walk 2 Direction	N/A
N/A	X Walk 1 Width (in)	N/A	N/A	X Walk 2 Width (in)	N/A
	X Walk 1 Slope (%)	3.1		X Walk 2 Slope (%)	N/A
	X Walk 1 X Slope (%)	1.5		X Walk 2 X Slope (%)	N/A

N/A	Ramp inside XWalk1?	N/A	N/A	Ramp inside XWalk2?	N/A
	Road Slope (%)	N/A	N/A	Clear Space?	N/A
	Road X Slope (%)	N/A	N/A	Clear Space to XWalk (in)	N/A
N/A	Any Obstructions?	N/A	N/A	Storm Grate/Utility Hazard?	N/A
	Obstruction Type			Storm Grate/Utility Type	
		N/A			N/A
			Yes	Surface Condition? (G/P)	Good

Possible Solutions:

Remove & Replace Entire Ramp.
