Access Compliance Report

Public Rights-of-Way

Intersection ID: 11514	Main Street: E_20TH_ST	Cross Street: N_MCDOWELL_ST	Location: E
ADA ID: B419EBB0106B	Ramp Type: PerpDiag	Initial Pass/Fail: Fail	Overall Compliance: No
			Severity Score: 48.75

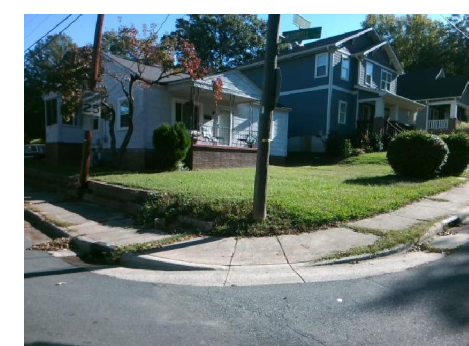
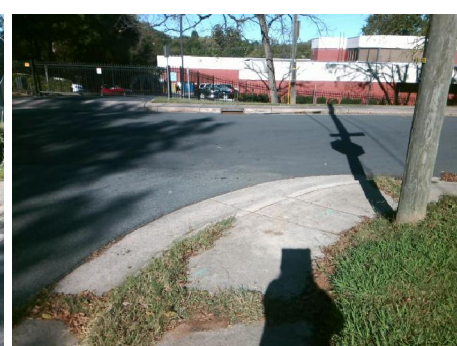
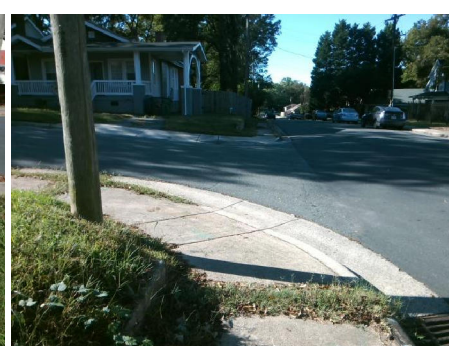
Possible Solutions:		Compliance	Description	Data
	Remove & Replace Curb Ramp With Two New Directional Ramps or Equivalent.		No	Ramp Length (in)	52.0
			No	Ramp Width (in)	27.5
			N/A	Flare Type LT	N/A
			N/A	Flare Slope LT (%)	N/A
			N/A	Flare Traversable LT?	N/A
			N/A	Landing Length (in)	N/A
			N/A	Landing Width (in)	N/A
			N/A	Landing Slope (%)	N/A
			N/A	Landing X Slope (%)	N/A
<p>Surveyor Notes:</p> <p>N/A</p> <p>PROW/ADA:</p> <p>Not Found, R304.5.1, R304.2.2, R304.5.3</p>			N/A	Flare Type RT	N/A
			N/A	Flare Slope RT (%)	N/A
			N/A	Flare Traversable RT?	N/A
			N/A	DWS Provided?	N/A
			N/A	DWS Contrast?	N/A
			N/A	DWS Length (in)	N/A
			N/A	DWS Full Width?	N/A
			N/A	DWS Offset (in)	N/A
			N/A	Gutter Ponding?	N/A
			N/A	Gutter Lip Ht (in)	0.5
			No	Painted X Walk1?	No
				X Walk 1 Direction	To NW
			N/A	X Walk 1 Width (in)	N/A

1.4	X Walk 1 Slope (%)	1.4
			0.1	X Walk 1 X Slope (%)	7.1
			N/A	Ramp inside XWalk1?	N/A
			5.3	Road Slope (%)	N/A
			2.2	Road X Slope (%)	N/A
			N/A	Any Obstructions?	N/A
				Obstruction Type	
Total Cost: \$ 3200.00			N/A	Storm Grate/Utility Hazard?	N/A
			N/A	Storm Grate/Utility Type	
			N/A		N/A
			Yes	Surface Condition? (G/P)	Good
