Access Compliance Report

Public Rights-of-Way

(Curb Ramps)

Intersection ID: 14925	Main Street: BROMLEY_RD	Cross Street: QUEENS_RD	Location: NW
ADA ID: B41C5B0B97B5	Ramp Type: Perp	Initial Pass/Fail: Fail	Overall Compliance: No
Severity Score: 37.5			
Codes/Mitigation Info/Possible Solution		Field Measurements/Component Compliance

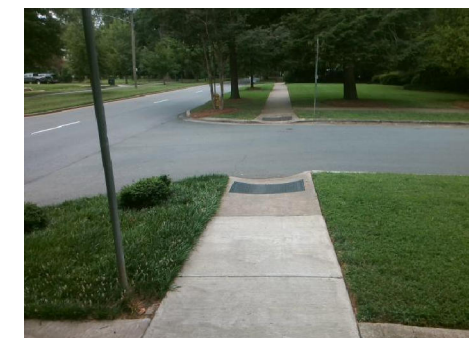
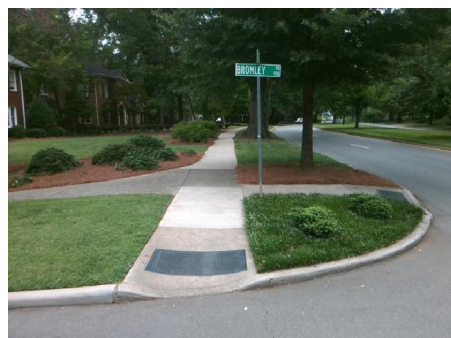
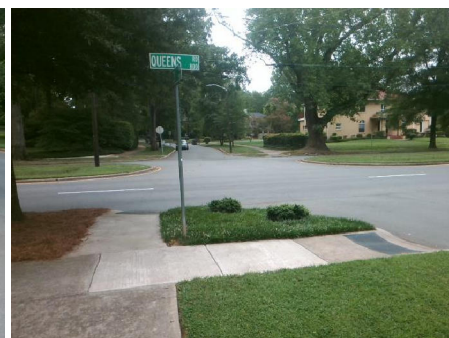
Not Found, R304.2.2, R304.5.3

Compliance	Description	Data	Compliance	Description	Data
N/A	Ramp Length (in)	70.0	No	Ramp Slope (%)	9.0
Yes	Ramp Width (in)	48.0	No	Ramp XSlope (%)	8.4
N/A	Flare Type LT	N/A	N/A	Flare Type RT	N/A
N/A	Flare Slope LT (%)	N/A	N/A	Flare Slope RT (%)	N/A
N/A	Flare Traversable LT?	N/A	N/A	Flare Traversable RT?	N/A
N/A	Landing Length (in)	N/A	N/A	DWS Provided?	N/A
N/A	Landing Width (in)	N/A	N/A	DWS Contrast?	N/A
N/A	Landing Slope (%)	N/A	N/A	DWS Length (in)	N/A
N/A	Landing X Slope (%)	N/A	N/A	DWS Full Width?	N/A
N/A	Landing Curb? (Y/N)	N/A	N/A	DWS Offset (in)	N/A
N/A	Shared Landing?	N/A			
N/A	Gutter Ponding?	N/A	N/A	Gutter Slope (%)	N/A
N/A	Gutter Lip Ht (in)	N/A	N/A	Gutter X Slope (%)	N/A
N/A	Painted X Walk1?	No	N/A	Painted X Walk2?	N/A
	X Walk 1 Direction	To SW		X Walk 2 Direction	N/A
N/A	X Walk 1 Width (in)	N/A	N/A	X Walk 2 Width (in)	N/A
	X Walk 1 Slope (%)	1.1		X Walk 2 Slope (%)	N/A
	X Walk 1 X Slope (%)	0.2		X Walk 2 X Slope (%)	N/A

N/A	Ramp inside XWalk1?	N/A	N/A	Ramp inside XWalk2?	N/A
	Road Slope (%)	N/A	N/A	Clear Space?	N/A
	Road X Slope (%)	N/A	N/A	Clear Space to XWalk (in)	N/A
N/A	Any Obstructions?	N/A	N/A	Storm Grate/Utility Hazard?	N/A
	Obstruction Type			Storm Grate/Utility Type	
		N/A			N/A
			Yes	Surface Condition? (G/P)	Good

Remove & Replace Entire Ramp.
