# Access Compliance Report

## Public Rights-of-Way

### (Curb Ramps)

Intersection ID: 10019463	Main Street: ALEXANDER_MARTIN_AV	Cross Street: N/A	Location: SE
ADA ID: B41E4EFB5E4F	Ramp Type: Perp	Initial Pass/Fail: Fail	Overall Compliance: No
		Severity Score: 12.5

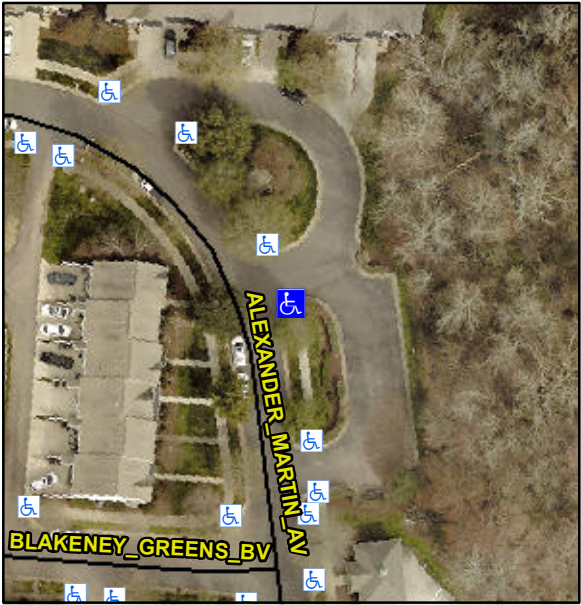
Possible Solutions:		<b>Compliance</b>	<b>Description</b>	<b>Data</b>
	<b>Remove &amp; Replace Entire Ramp.</b>		<b>No</b>	Ramp Length (in)	61.0
			<b>Yes</b>	Ramp Width (in)	59.0
			<b>N/A</b>	Flare Type LT	N/A
			<b>N/A</b>	Flare Slope LT (%)	N/A
			<b>N/A</b>	Flare Traversable LT?	N/A
			<b>N/A</b>	Landing Length (in)	N/A
			<b>N/A</b>	Landing Width (in)	N/A
			<b>N/A</b>	Landing Slope (%)	N/A
			<b>N/A</b>	Landing X Slope (%)	N/A
<p>Surveyor Notes:</p> <p><b>N/A</b></p> <p>PROW/ADA:</p> <p><b>R304.2.2</b></p>			<b>N/A</b>	Flare Type RT	N/A
			<b>N/A</b>	Flare Slope RT (%)	N/A
			<b>N/A</b>	Flare Traversable RT?	N/A
			<b>N/A</b>	DWS Provided?	N/A
			<b>N/A</b>	DWS Contrast?	N/A
			<b>N/A</b>	DWS Length (in)	N/A
			<b>N/A</b>	DWS Full Width?	N/A
			<b>N/A</b>	DWS Offset (in)	N/A
			<b>N/A</b>	Shared Landing?	N/A
			<b>N/A</b>	Gutter Ponding?	N/A

<b>N/A</b>	Gutter Lip Ht (in)	N/A
			<b>N/A</b>	Painted X Walk1?	No
				X Walk 1 Direction	To NW
			<b>N/A</b>	X Walk 1 Width (in)	N/A
				X Walk 1 Slope (%)	2.1
				X Walk 1 X Slope (%)	0.6
			<b>N/A</b>	Ramp inside XWalk1?	N/A
			<b>N/A</b>	Road Slope (%)	N/A
			<b>N/A</b>	Road X Slope (%)	N/A
			<b>N/A</b>	Any Obstructions?	N/A
				Obstruction Type	
			<b>N/A</b>		
			<b>N/A</b>		
			<b>N/A</b>		
			<b>N/A</b>		
			<b>N/A</b>		
			<b>N/A</b>		
			<b>N/A</b>		
			<b>N/A</b>		
			<b>N/A</b>		
Total Cost:		\$ 1850.00			
Street 1 Name	N/A				
Stop Condition-Street 2	None				
Street 2 Name	N/A				
Stop Condition-Street 1	N/A				
			<b>N/A</b>		
			<b>Yes</b>	Surface Condition? (G/P)	Good
