Access Compliance Report

Public Rights-of-Way (Curb Ramps)

Intersection ID: 15147	Main Street: QUEENS_RD	Cross Street: EDGEHILL_RD_SOUTH	Location: NE
ADA ID: B421A4B0E7B3	Ramp Type: PerpDiag	Initial Pass/Fail: Fail	Overall Compliance: No
		Severity Score: 8.75

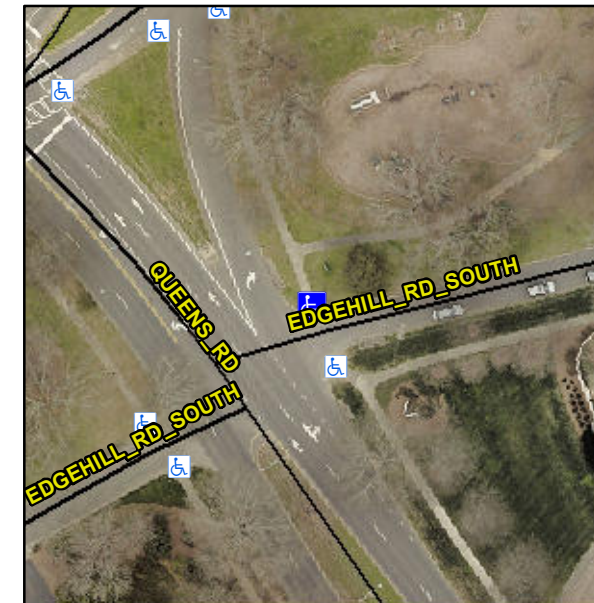
Compliance	Description	Data	Compliance	Description	Data
N/A	Ramp Length (in)	61.0	Yes	Ramp Slope (%)	5.2
No	Ramp Width (in)	38.0	Yes	Ramp XSlope (%)	0.5
N/A	Flare Type LT	N/A	N/A	Flare Type RT	N/A
N/A	Flare Slope LT (%)	N/A	N/A	Flare Slope RT (%)	N/A
N/A	Flare Traversable LT?	N/A	N/A	Flare Traversable RT?	N/A
N/A	Landing Length (in)	N/A	N/A	DWS Provided?	N/A
N/A	Landing Width (in)	N/A	N/A	DWS Contrast?	N/A
N/A	Landing Slope (%)	N/A	N/A	DWS Length (in)	N/A
N/A	Landing X Slope (%)	N/A	N/A	DWS Full Width?	N/A
N/A	Landing Curb? (Y/N)	N/A	N/A	DWS Offset (in)	N/A
N/A	Shared Landing?	N/A			
N/A	Gutter Ponding?	N/A	N/A	Gutter Slope (%)	N/A
N/A	Gutter Lip Ht (in)	N/A	N/A	Gutter X Slope (%)	N/A
N/A	Painted X Walk1?	No	N/A	Painted X Walk2?	No
	X Walk 1 Direction	To SW		X Walk 2 Direction	To S
N/A	X Walk 1 Width (in)	N/A	N/A	X Walk 2 Width (in)	N/A
	X Walk 1 Slope (%)	0.3		X Walk 2 Slope (%)	1.6
	X Walk 1 X Slope (%)	0.7		X Walk 2 X Slope (%)	0.7

N/A	Ramp inside XWalk1?	N/A	N/A	Ramp inside XWalk2?	N/A
	Road Slope (%)	0.4	N/A	Clear Space?	N/A
	Road X Slope (%)	2.0	N/A	Clear Space to XWalk (in)	N/A
N/A	Any Obstructions?	N/A	N/A	Storm Grate/Utility Hazard?	N/A
	Obstruction Type			Storm Grate/Utility Type	
		N/A			N/A
			Yes	Surface Condition? (G/P)	Good

Remove & Replace Curb Ramp With Two New Directional Ramps or Equivalent.

R304.5.1
