Access Compliance Report

Public Rights-of-Way

(Curb Ramps)

| Intersection ID: 13644 | Main Street: BEECH_NUT_RD | Cross Street: WEST_BV | Location: SW |

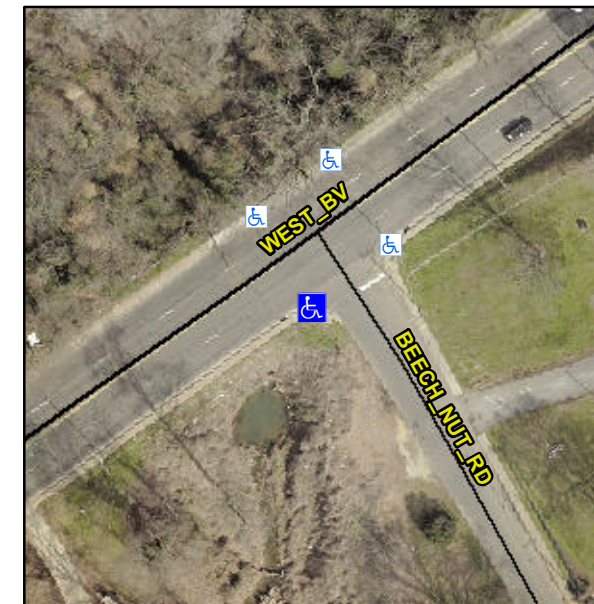
| ADA ID: B4270570F917 | Ramp Type: PerpDiag | Initial Pass/Fail: Fail | Overall Compliance: No |
| | | Severity Score: 10 | |

Not Found, R304.5.1, R304.5.3

| Compliance | Description | Data | Compliance | Description | Data |
|---|---|---|---|---|---|
| N/A | Ramp Length (in) | 49.0 | Yes | Ramp Slope (%) | 6.6 |
| No | Ramp Width (in) | 46.0 | No | Ramp XSlope (%) | 4.5 |

Remove & Replace Curb Ramp With Two New Directional Ramps or Equivalent.
