Access Compliance Report

Public Rights-of-Way

(Curb Ramps)

| Intersection ID: 52573 | Main Street: NEW_RENAISSANCE_WY | Cross Street: NOBLES_AV | Location: SW |

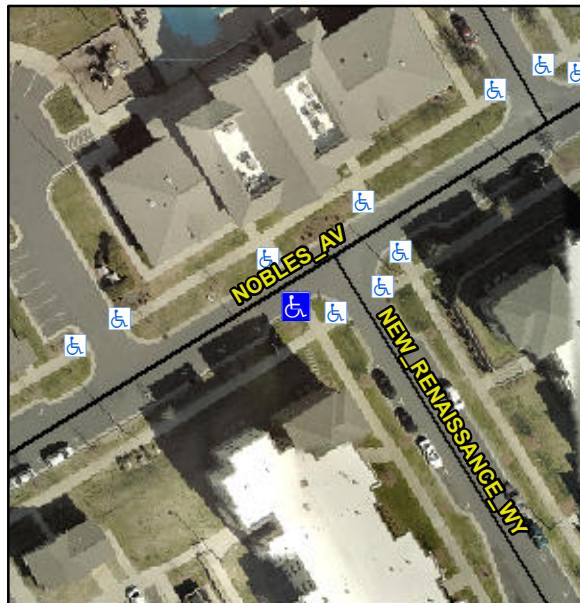
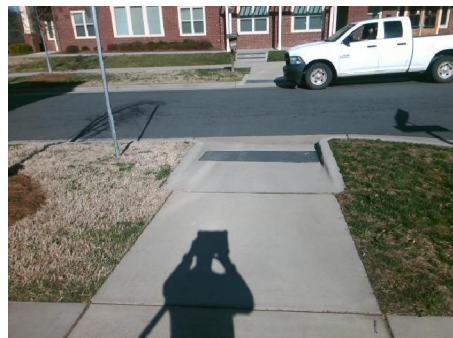
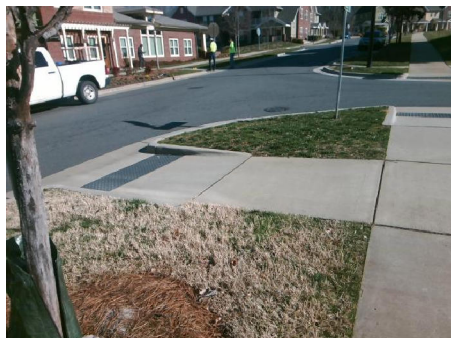
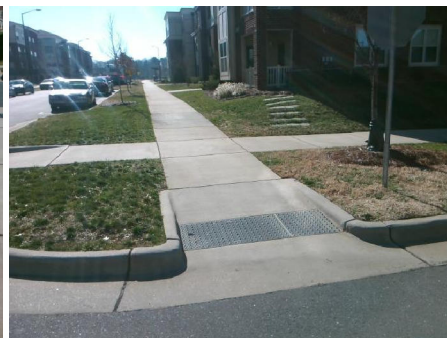
| ADA ID: B42E69077029 | Ramp Type: Perp | Initial Pass/Fail: Fail | Overall Compliance: No |

| Compliance | Description | Data | Compliance | Description | Data |
|---|---|---|---|---|---|
| N/A | Ramp Length (in) | 71.5 | No | Ramp Slope (%) | 9.8 |
| Yes | Ramp Width (in) | 70.0 | No | Ramp XSlope (%) | 2.2 |

Remove & Replace Entire Ramp.

R304.2.2, R304.5.3
