# Access Compliance Report

## Public Rights-of-Way

### (Curb Ramps)

Intersection ID: 14366	Main Street: E_KINGSTON_AV	Cross Street: WINTHROP_AV	Location:	N
ADA ID: B441CEF59EEF	Ramp Type: Directional1	Initial Pass/Fail: Fail	Overall Compliance: No	Severity Score: 22.5

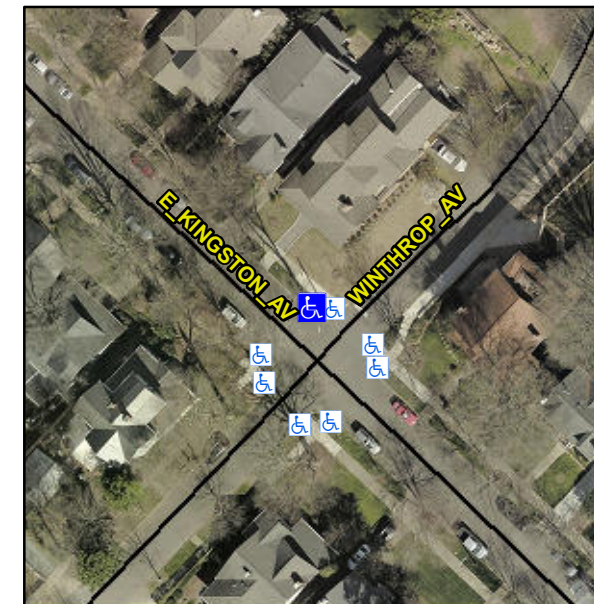
**LNDG GAP 1.0"**

Compliance	Description	Data	Compliance	Description	Data
N/A	Ramp Length (in)	68.0	N/A	Grade Break?	N/A
No	Ramp Width (in)	36.0	N/A	Grade Break Slope (%)	0.0
No	Ramp Slope (%)	9.2	N/A	Grade Break XSlope (%)	0.0
No	Ramp XSlope (%)	4.2			
N/A	Flare Type LT	N/A	N/A	Flare Type RT	N/A
N/A	Flare Slope LT (%)	N/A	N/A	Flare Slope RT (%)	0.0
N/A	Flare Traversable LT?	N/A	N/A	Flare Traversable RT?	N/A
N/A	Landing Length (in)	0.0	N/A	DWS Provided?	N/A
N/A	Landing Width (in)	0.0	N/A	DWS Contrast?	N/A
N/A	Landing Slope (%)	0.0	N/A	DWS Length (in)	N/A
N/A	Landing X Slope (%)	0.0	N/A	DWS Full Width?	N/A
N/A	Landing Curb? (Y/N)	N/A	N/A	DWS Offset LT (in)	N/A
N/A	Shared Landing?	N/A	N/A	DWS Offset RT (in)	N/A
N/A	Gutter Ponding?	Yes	N/A	Gutter Slope (%)	N/A
N/A	Gutter Lip Ht (in)	0.0	N/A	Gutter X Slope (%)	N/A
N/A	Painted X Walk1?	No		Road Slope (%)	7.5
	X Walk 1 Direction	To SW		Road X Slope (%)	0.9
	X Walk 1 Width (in)	N/A		Clear Space?	N/A

X Walk 1 Slope (%)	7.5	N/A	Clear Space to XWalk (in)	N/A
	X Walk 1 X Slope (%)	0.9	N/A	Storm Grate/Utility Hazard?	N/A
N/A	Ramp inside XWalk1?	N/A		Storm Grate/Utility Type	
N/A	Any Obstructions?	N/A			N/A
	Obstruction Type		Yes	Surface Condition? (G/P)	Good
			N/A	Curb Slope (%)	0.7

**Remove & Replace Entire Ramp.**
