Access Compliance Report

Public Rights-of-Way

(Curb Ramps)

| Intersection ID: 26426 | Main Street: BRECHIN_DR | Cross Street: FORTROSE_LN | Location: NE |

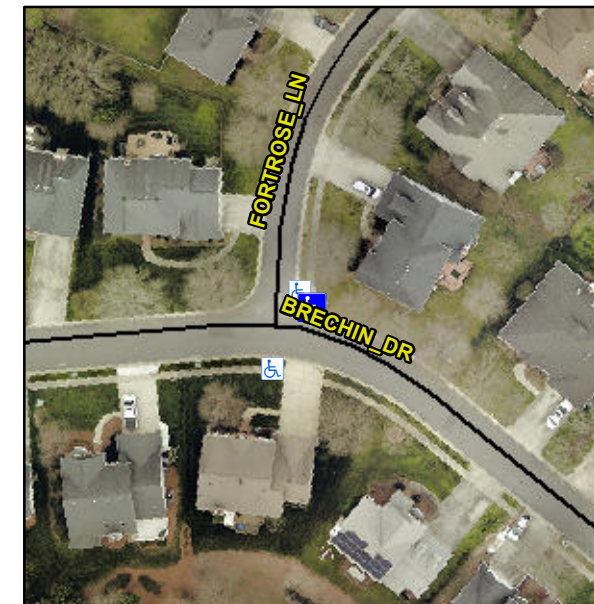
| ADA ID: B441F8D304F6 | Ramp Type: Perp | Initial Pass/Fail: Fail | Overall Compliance: No |

R304.2.2

| Compliance | Description | Data | Compliance | Description | Data |
|---|---|---|---|---|---|
| N/A | Ramp Length (in) | 47.0 | No | Ramp Slope (%) | 9.1 |

Remove & Replace Entire Ramp.
