# Access Compliance Report

## Public Rights-of-Way

### (Curb Ramps)

Intersection ID: 15031	Main Street: OPTIMIST_LN	Cross Street: WESTCHESTER_BV	Location: S
ADA ID: B4442146F8FB	Ramp Type: BlendTrans1	Initial Pass/Fail: Fail	Overall Compliance: No
Severity Score: 1.25			
Codes/Mitigation Info/Possible Solution		Field Measurements/Component Compliance

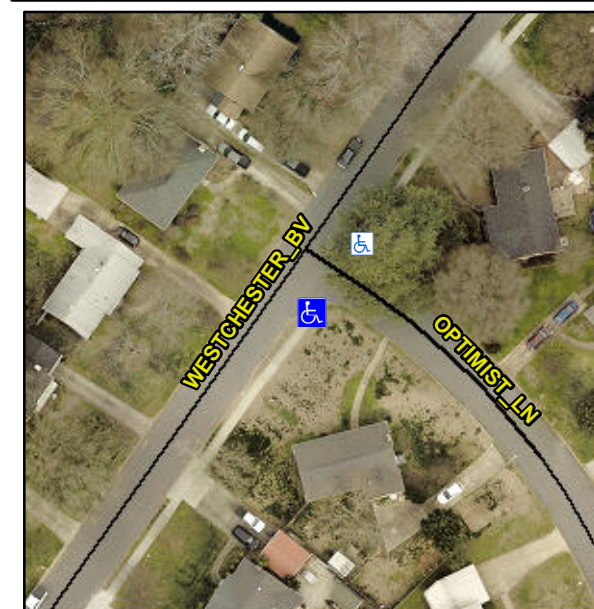
Compliance	Description	Data	Compliance	Description	Data
N/A	Ramp Length (in)	75.0	Yes	BlendTrans Slope (%)	4.0
Yes	Ramp Width (in)	59.0	No	BlendTrans XSlope (%)	2.4
N/A	Flare Type LT	N/A	N/A	Flare Type RT	N/A
N/A	Flare Slope LT (%)	N/A	N/A	Flare Slope RT (%)	N/A
N/A	Flare Traversable LT?	N/A	N/A	Flare Traversable RT?	N/A
N/A	Landing Length (in)	N/A	N/A	DWS Provided?	N/A
N/A	Landing Width (in)	N/A	N/A	DWS Contrast?	N/A
N/A	Landing Slope (%)	N/A	N/A	DWS Length (in)	N/A
N/A	Landing X Slope (%)	N/A	N/A	DWS Full Width?	N/A
N/A	Landing Curb? (Y/N)	N/A	N/A	DWS Offset (in)	N/A
N/A	Shared Landing?	N/A			
N/A	Gutter Ponding?	N/A	N/A	Gutter Slope (%)	N/A
N/A	Gutter Lip Ht (in)	N/A	N/A	Gutter X Slope (%)	N/A
N/A	Painted X Walk1?	No	N/A	Painted X Walk2?	N/A
	X Walk 1 Direction	To NE		X Walk 2 Direction	N/A
	X Walk 1 Width (in)	N/A		X Walk 2 Width (in)	N/A
	X Walk 1 Slope (%)	4.4		X Walk 2 Slope (%)	N/A
	X Walk 1 X Slope (%)	4.6		X Walk 2 X Slope (%)	N/A

N/A	Ramp inside XWalk1?	N/A	N/A	Ramp inside XWalk2?	N/A
	Road Slope (%)	4.6		Clear Space?	N/A
	Road X Slope (%)	4.4	N/A	Clear Space to XWalk (in)	N/A
N/A	Any Obstructions?	N/A	N/A	Storm Grate/Utility Hazard?	N/A
	Obstruction Type			Storm Grate/Utility Type	
		N/A			N/A
			Yes	Surface Condition? (G/P)	Good
			N/A	Curb Slope (%)	0.4

Possible Solutions:

**Remove & Replace Curb Ramp With Two New Directional Ramps or Equivalent.**

**R304.5.3**

**\$ 3200.00**

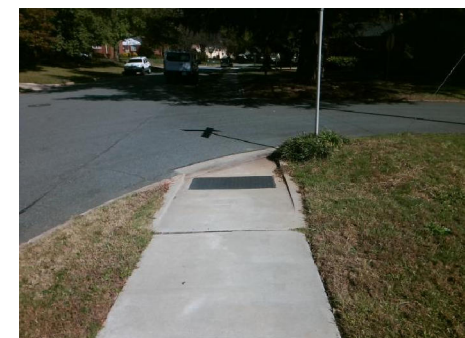
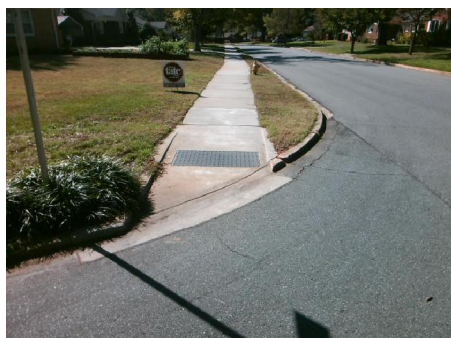
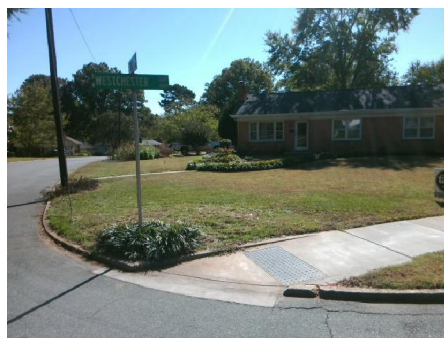
Street 1 Name OPTIMIST LN  
 Stop Condition-Street 1 StopSign  
 Street 2 Name N/A  
 Stop Condition-Street 2 N/A
