Access Compliance Report

Public Rights-of-Way

(Curb Ramps)

| Intersection ID: 17995 | Main Street: FIELDBROOK_PL | Cross Street: WESTFIELD_RD | Location: W |

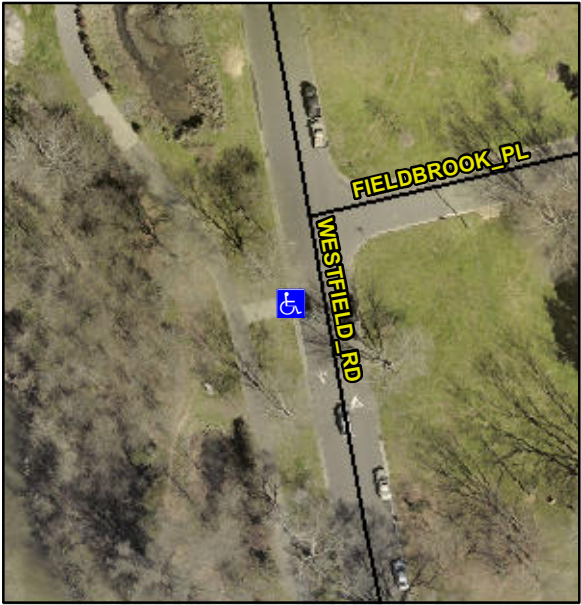
| ADA ID: B4449F1A5AA8 | Ramp Type: Perp | Initial Pass/Fail: Fail | Overall Compliance: No |
| | | | Severity Score: 13.75 |

| Codes/Mitigation Info/Possible Solution | | | Field Measurements/Component Compliance | | |
|--|---|--|---|---|---|
| <p>Surveyor Notes:</p> <p>N/A</p> <p>PROW/ADA:</p> <p>R304.2.2, R304.5.3</p> | | | N/A | Flare Type RT | N/A |
| | | | | X Walk 1 Slope (%) | 7.0 |

| Codes/Mitigation Info/Possible Solution | | | Field Measurements/Component Compliance | | |
|--|---|--|---|---|---|
| | Remove & Replace Entire Ramp. | | N/A | Ramp Length (in) | 79.0 |
| <p>Total Cost:</p> <p>\$ 1850.00</p> | | | No | Painted X Walk1? | N/A |
