# Access Compliance Report

## Public Rights-of-Way

### (Curb Ramps)

Intersection ID: 10027081	Main Street: GALLERIA_BV	Cross Street: N/A	Location: SE
ADA ID: B4452283CD20	Ramp Type: PerpDiag	Initial Pass/Fail: Fail	Overall Compliance: No
Codes/Mitigation Info/Possible Solution		Field Measurements/Component Compliance

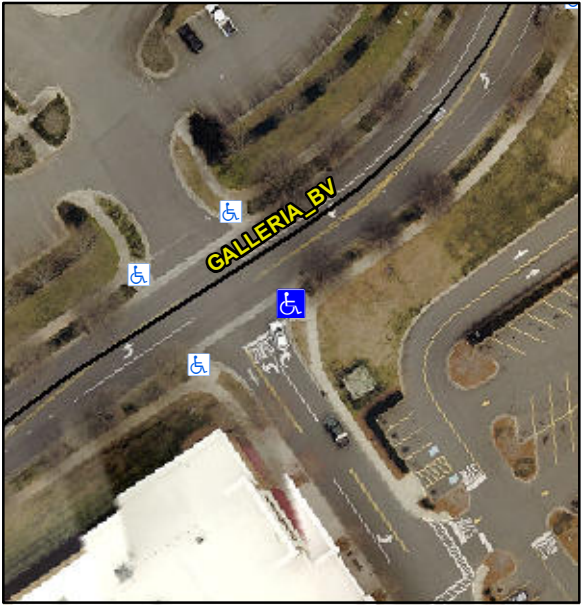
Possible Solutions:						
	<b>Remove &amp; Replace Curb Ramp With Two New Directional Ramps or Equivalent.</b>	<b>Compliance</b>	<b>Description</b>	<b>Data</b>	<b>Compliance</b>	<b>Description</b>	<b>Data</b>
		N/A	Ramp Length (in)	94.0	No	Ramp Slope (%)	9.0
		No	Ramp Width (in)	36.0	No	Ramp XSlope (%)	4.2
		N/A	Flare Type LT	N/A	N/A	Flare Type RT	N/A
		N/A	Flare Slope LT (%)	N/A	N/A	Flare Slope RT (%)	N/A
		N/A	Flare Traversable LT?	N/A	N/A	Flare Traversable RT?	N/A
		N/A	Landing Length (in)	N/A	N/A	DWS Provided?	N/A
		N/A	Landing Width (in)	N/A	N/A	DWS Contrast?	N/A
		N/A	Landing Slope (%)	N/A	N/A	DWS Length (in)	N/A
		N/A	Landing X Slope (%)	N/A	N/A	DWS Full Width?	N/A
		N/A	Landing Curb? (Y/N)	N/A	N/A	DWS Offset (in)	N/A
		N/A	Shared Landing?	N/A			
		N/A	Gutter Ponding?	N/A	N/A	Gutter Slope (%)	N/A
		N/A	Gutter Lip Ht (in)	N/A	N/A	Gutter X Slope (%)	N/A
		N/A	Painted X Walk1?	No	N/A	Painted X Walk2?	No

X Walk 1 Direction	To N		X Walk 2 Direction	To SW
		N/A	X Walk 1 Width (in)	N/A	N/A	X Walk 2 Width (in)	N/A
			X Walk 1 Slope (%)	4.0		X Walk 2 Slope (%)	1.5
			X Walk 1 X Slope (%)	2.5		X Walk 2 X Slope (%)	1.9
<p>Surveyor Notes:</p> <p><b>N/A</b></p> <p>PROW/ADA:</p> <p><b>Not Found, R304.5.1, R304.2.2, R304.5.3</b></p>		N/A	Ramp inside XWalk1?	N/A	N/A	Ramp inside XWalk2?	N/A
			Road Slope (%)	4.6	N/A	Clear Space?	N/A
			Road X Slope (%)	2.3	N/A	Clear Space to XWalk (in)	N/A
		N/A	Any Obstructions?	N/A	N/A	Storm Grate/Utility Hazard?	N/A
			Obstruction Type			Storm Grate/Utility Type	
				N/A			N/A
					Yes	Surface Condition? (G/P)	Good
Total Cost:		\$	3200.00
