# Access Compliance Report

## Public Rights-of-Way

### (Curb Ramps)

| ADA ID: B4640BDCC607 | Ramp Type: Perp | Initial Pass/Fail: Pass | Overall Compliance: No |

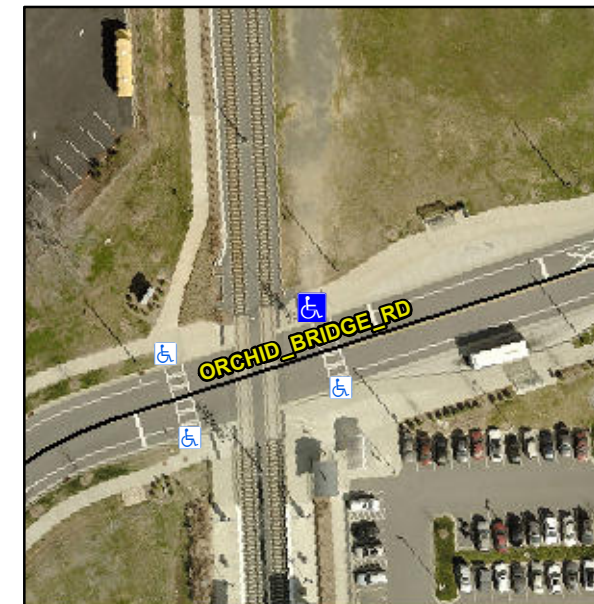
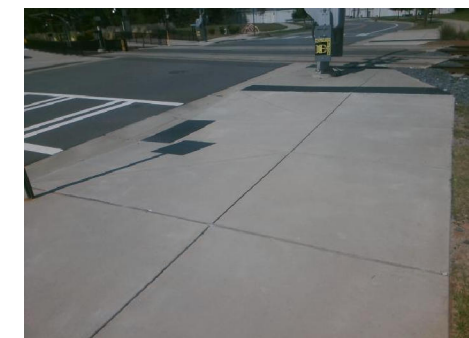
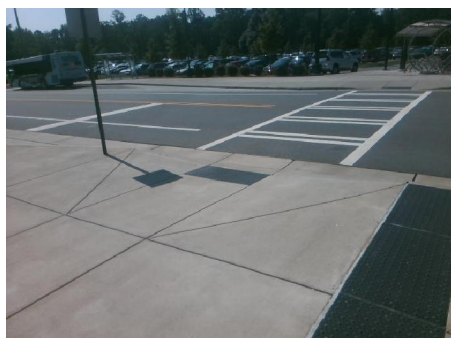
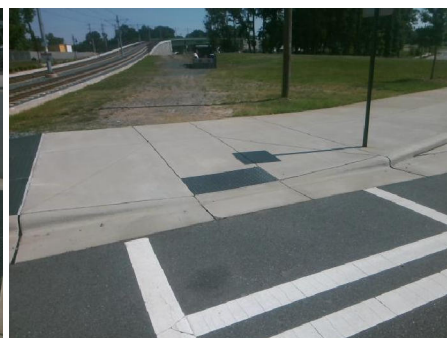
**R304.5.3**

| Compliance | Description | Data | Compliance | Description | Data |
|---|---|---|---|---|---|
| Yes | Ramp Width (in) | 49.5 | No | Ramp XSlope (%) | 4.6 |
| No | Landing X Slope (%) | 3.5 | Yes | DWS Full Width? | Yes |
| Yes | Gutter Lip Ht (in) | 0.0 | No | Gutter X Slope (%) | 3.3 |

**Remove & Replace Entire Ramp.  
Remove & Replace Gutter.**

**\$ 2600.00**
