# Access Compliance Report

## Public Rights-of-Way

### (Curb Ramps)

Intersection ID: 20439	Main Street: FAIRVIEW_RD	Cross Street: SHARON_RD	Location: SE
ADA ID: B47F8CF6121D	Ramp Type: BlendTrans2	Initial Pass/Fail: Fail	Overall Compliance: No
Codes/Mitigation Info/Possible Solution			Severity Score: 10
			Field Measurements/Component Compliance

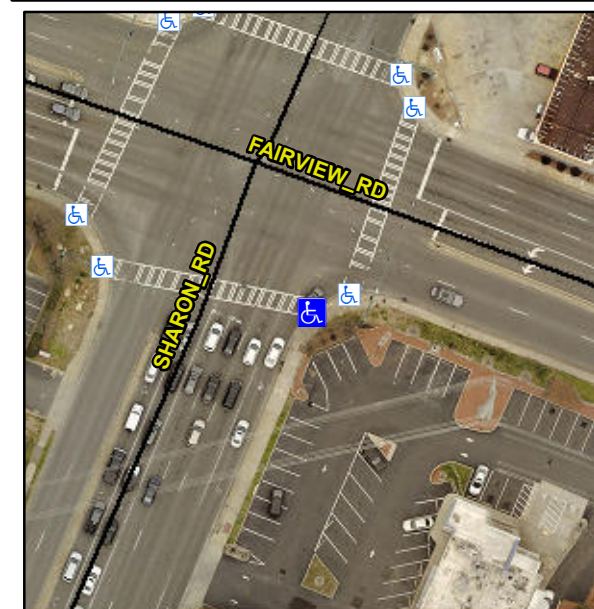
**R304.5.1, R304.5.3**

Compliance	Description	Data	Compliance	Description	Data
N/A	Ramp Length (in)	94.0	Yes	BlendTrans Slope (%)	4.1
No	Ramp Width (in)	37.0	No	BlendTrans XSlope (%)	4.3
N/A	Flare Type LT	N/A	N/A	Flare Type RT	N/A
N/A	Flare Slope LT (%)	N/A	N/A	Flare Slope RT (%)	N/A
N/A	Flare Traversable LT?	N/A	N/A	Flare Traversable RT?	N/A
N/A	Landing Length (in)	N/A	N/A	DWS Provided?	N/A
N/A	Landing Width (in)	N/A	N/A	DWS Contrast?	N/A
N/A	Landing Slope (%)	N/A	N/A	DWS Length (in)	N/A
N/A	Landing X Slope (%)	N/A	N/A	DWS Full Width?	N/A
N/A	Landing Curb? (Y/N)	N/A	N/A	DWS Offset (in)	N/A
N/A	Shared Landing?	N/A			
N/A	Gutter Ponding?	N/A	N/A	Gutter Slope (%)	N/A
N/A	Gutter Lip Ht (in)	1.0	N/A	Gutter X Slope (%)	N/A
N/A	Painted X Walk1?	Yes	N/A	Painted X Walk2?	N/A
	X Walk 1 Direction	To NW		X Walk 2 Direction	N/A
	X Walk 1 Width (in)	100.0		X Walk 2 Width (in)	N/A
	X Walk 1 Slope (%)	2.7		X Walk 2 Slope (%)	N/A
	X Walk 1 X Slope (%)	1.8		X Walk 2 X Slope (%)	N/A

N/A	Ramp inside XWalk1?	Yes	N/A	Ramp inside XWalk2?	N/A
	Road Slope (%)	1.8		Clear Space?	N/A
	Road X Slope (%)	2.7	N/A	Clear Space to XWalk (in)	N/A
N/A	Any Obstructions?	N/A	N/A	Storm Grate/Utility Hazard?	N/A
	Obstruction Type			Storm Grate/Utility Type	
		N/A			N/A
			Yes	Surface Condition? (G/P)	Good
			N/A	Curb Slope (%)	1.9

**Remove & Replace Curb Ramp With Two New Directional Ramps or Equivalent.**
