Access Compliance Report

Public Rights-of-Way

(Curb Ramps)

Intersection ID: 31707	Main Street: ATLAS_CEDAR_DR	Cross Street: WEEPING_FIG_LN	Location: SE
ADA ID: B47FC7690549	Ramp Type: PerpDiag	Initial Pass/Fail: Fail	Overall Compliance: No
Severity Score: 22.5			
Codes/Mitigation Info/Possible Solution		Field Measurements/Component Compliance

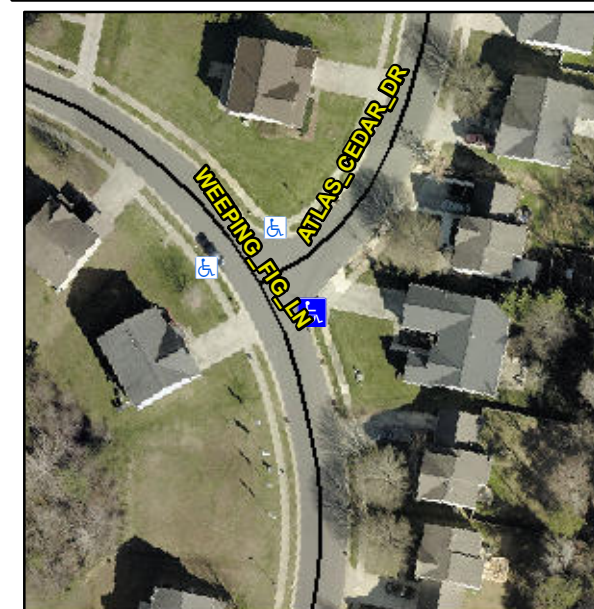
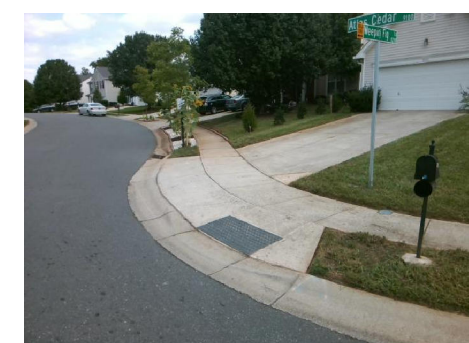
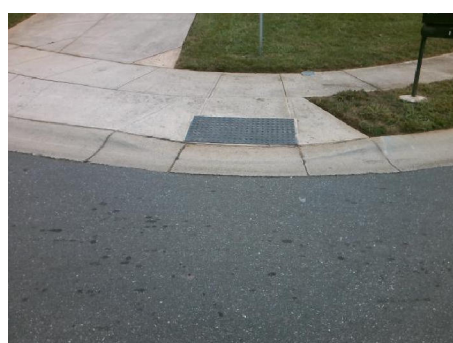
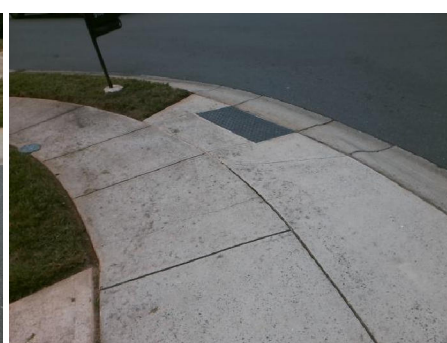
Not Found, R304.5.1, R304.2.2, R304.5.3

Compliance	Description	Data	Compliance	Description	Data
N/A	Ramp Length (in)	45.5	No	Ramp Slope (%)	11.1
No	Ramp Width (in)	41.0	No	Ramp XSlope (%)	3.8
N/A	Flare Type LT	N/A	N/A	Flare Type RT	N/A
N/A	Flare Slope LT (%)	N/A	N/A	Flare Slope RT (%)	N/A
N/A	Flare Traversable LT?	N/A	N/A	Flare Traversable RT?	N/A
N/A	Landing Length (in)	N/A	N/A	DWS Provided?	N/A
N/A	Landing Width (in)	N/A	N/A	DWS Contrast?	N/A
N/A	Landing Slope (%)	N/A	N/A	DWS Length (in)	N/A
N/A	Landing X Slope (%)	N/A	N/A	DWS Full Width?	N/A
N/A	Landing Curb? (Y/N)	N/A	N/A	DWS Offset (in)	N/A
N/A	Shared Landing?	N/A			
N/A	Gutter Ponding?	N/A	N/A	Gutter Slope (%)	N/A
N/A	Gutter Lip Ht (in)	N/A	N/A	Gutter X Slope (%)	N/A
N/A	Painted X Walk1?	No	N/A	Painted X Walk2?	No
	X Walk 1 Direction	To N		X Walk 2 Direction	To W
N/A	X Walk 1 Width (in)	N/A	N/A	X Walk 2 Width (in)	N/A
	X Walk 1 Slope (%)	3.0		X Walk 2 Slope (%)	2.1
	X Walk 1 X Slope (%)	1.2		X Walk 2 X Slope (%)	3.4

N/A	Ramp inside XWalk1?	N/A	N/A	Ramp inside XWalk2?	N/A
	Road Slope (%)	2.1	N/A	Clear Space?	N/A
	Road X Slope (%)	5.5	N/A	Clear Space to XWalk (in)	N/A
N/A	Any Obstructions?	N/A	N/A	Storm Grate/Utility Hazard?	N/A
	Obstruction Type			Storm Grate/Utility Type	
		N/A			N/A
			Yes	Surface Condition? (G/P)	Good

Remove & Replace Curb Ramp With Two New Directional Ramps or Equivalent.
