# Access Compliance Report

## Public Rights-of-Way

### (Curb Ramps)

Intersection ID: 9610	Main Street: BARRINGTON_DR	Cross Street: THE_PLAZA	Location: SW
ADA ID: B482A38CFEAA	Ramp Type: ParaDiag	Initial Pass/Fail: Fail	Overall Compliance: No
Severity Score: 15			
Codes/Mitigation Info/Possible Solution		Field Measurements/Component Compliance

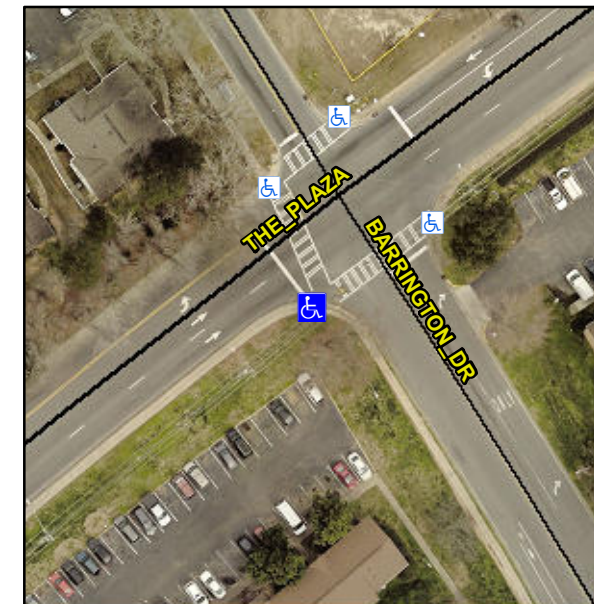
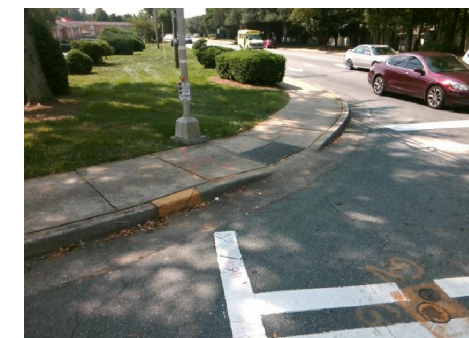
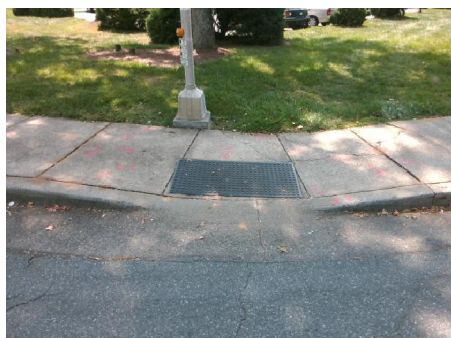
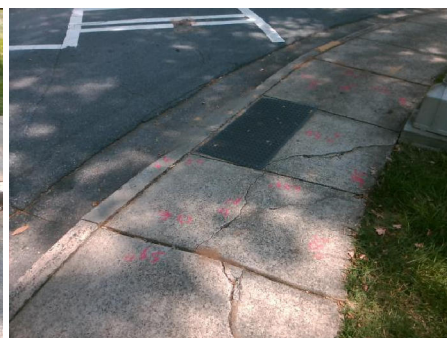
**DAMAGED SURFACE**

**Not Found, R302.7**

Compliance	Description	Data	Compliance	Description	Data
N/A	Ramp Length LT (in)	44.0	N/A	Ramp Length RT (in)	38.0
Yes	Ramp Width LT (in)	59.5	Yes	Ramp Width RT (in)	59.0
Yes	Ramp Slope LT (%)	5.8	Yes	Ramp Slope RT (%)	5.2
Yes	Ramp XSlope LT (%)	0.2	Yes	Ramp XSlope RT (%)	0.6
N/A	Landing Length (in)	N/A	N/A	DWS Provided?	N/A
N/A	Landing Width (in)	N/A	N/A	DWS Contrast?	N/A
N/A	Landing Slope (%)	N/A	N/A	DWS Length (in)	N/A
N/A	Landing X Slope (%)	N/A	N/A	DWS Full Width?	N/A
N/A	Landing Curb? (Y/N)	N/A	N/A	DWS Offset (in)	N/A
N/A	Shared Landing?	N/A			
N/A	Gutter Ponding?	N/A	N/A	Gutter Slope (%)	N/A
N/A	Gutter Lip Ht (in)	N/A	N/A	Gutter X Slope (%)	N/A
N/A	Painted X Walk1?	Yes	N/A	Painted X Walk2?	Yes
	X Walk 1 Direction	To NE		X Walk 2 Direction	To NW
N/A	X Walk 1 Width (in)	115.0	N/A	X Walk 2 Width (in)	114.5
	X Walk 1 Slope (%)	4.2		X Walk 2 Slope (%)	0.7
	X Walk 1 X Slope (%)	0.2		X Walk 2 X Slope (%)	3.8

N/A	Ramp inside XWalk1?	Yes	N/A	Ramp inside XWalk2?	Yes
	Road Slope (%)	1.6	N/A	Clear Space?	N/A
	Road X Slope (%)	5.2	N/A	Clear Space to XWalk (in)	N/A
N/A	Any Obstructions?	N/A	N/A	Storm Grate/Utility Hazard?	N/A
	Obstruction Type			Storm Grate/Utility Type	
		N/A			N/A
			No	Surface Condition? (G/P)	Poor
			Replace	Curb Slope (%)	15.3

**Remove & Replace Curb Ramp With Two New Directional Ramps or Equivalent.**
