# Access Compliance Report

## Public Rights-of-Way

### (Curb Ramps)

Intersection ID: 15725	Main Street: CLANTON_RD	Cross Street: S_TRYON_ST	Location: NE
ADA ID: B497FA830F74	Ramp Type: Perp	Initial Pass/Fail: Fail	Overall Compliance: No
Severity Score: 25			
Codes/Mitigation Info/Possible Solution		Field Measurements/Component Compliance

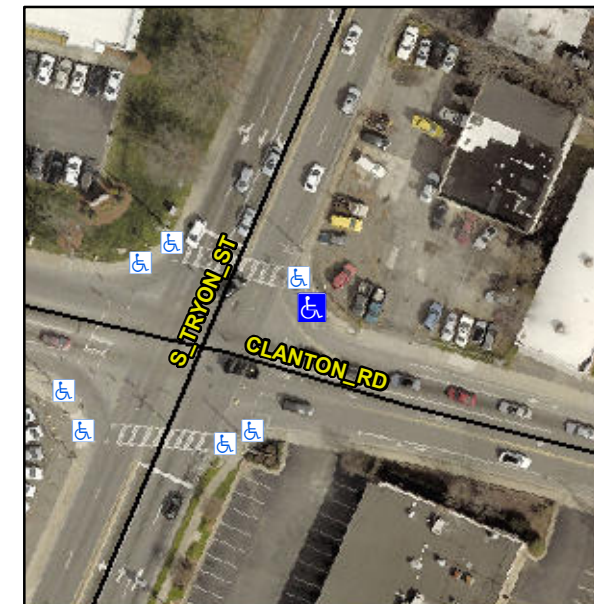
**Not Found, R304.2.2, R304.5.3**

Compliance	Description	Data	Compliance	Description	Data
N/A	Ramp Length (in)	61.0	No	Ramp Slope (%)	9.0
Yes	Ramp Width (in)	48.0	No	Ramp XSlope (%)	5.1
N/A	Flare Type LT	N/A	N/A	Flare Type RT	N/A
N/A	Flare Slope LT (%)	N/A	N/A	Flare Slope RT (%)	N/A
N/A	Flare Traversable LT?	N/A	N/A	Flare Traversable RT?	N/A
N/A	Landing Length (in)	N/A	N/A	DWS Provided?	N/A
N/A	Landing Width (in)	N/A	N/A	DWS Contrast?	N/A
N/A	Landing Slope (%)	N/A	N/A	DWS Length (in)	N/A
N/A	Landing X Slope (%)	N/A	N/A	DWS Full Width?	N/A
N/A	Landing Curb? (Y/N)	N/A	N/A	DWS Offset (in)	N/A
N/A	Shared Landing?	N/A			
N/A	Gutter Ponding?	N/A	N/A	Gutter Slope (%)	N/A
N/A	Gutter Lip Ht (in)	N/A	N/A	Gutter X Slope (%)	N/A
N/A	Painted X Walk1?	Yes	N/A	Painted X Walk2?	N/A
	X Walk 1 Direction	To SW		X Walk 2 Direction	N/A
N/A	X Walk 1 Width (in)	111.0	N/A	X Walk 2 Width (in)	N/A
	X Walk 1 Slope (%)	6.4		X Walk 2 Slope (%)	N/A
	X Walk 1 X Slope (%)	1.5		X Walk 2 X Slope (%)	N/A

N/A	Ramp inside XWalk1?	Yes	N/A	Ramp inside XWalk2?	N/A
	Road Slope (%)	N/A	N/A	Clear Space?	N/A
	Road X Slope (%)	N/A	N/A	Clear Space to XWalk (in)	N/A
N/A	Any Obstructions?	N/A	N/A	Storm Grate/Utility Hazard?	N/A
	Obstruction Type			Storm Grate/Utility Type	
		N/A			N/A
		Yes		Surface Condition? (G/P)	Good

**Remove & Replace Entire Ramp.**
