# Access Compliance Report

## Public Rights-of-Way

### (Curb Ramps)

Intersection ID: 11174	Main Street: HARRISBURG_RD	Cross Street: TIMBERTOP_LN	Location: S
ADA ID: B4A191385C4A	Ramp Type: Perp	Initial Pass/Fail: Fail	Overall Compliance: No
Severity Score: 28.75			
Codes/Mitigation Info/Possible Solution		Field Measurements/Component Compliance

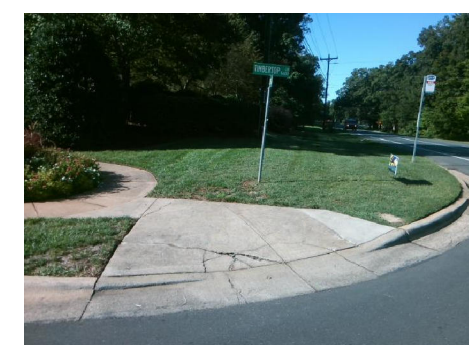
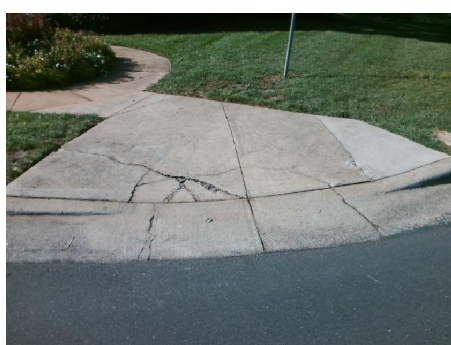
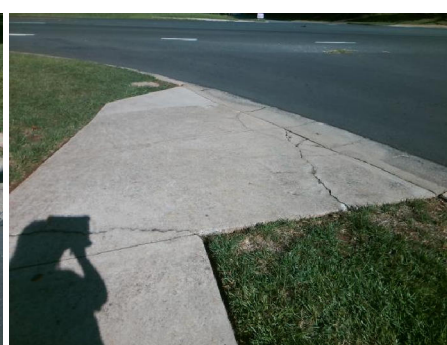
**Not Found, R304.2.2, R304.5.3, R302.7**

Compliance	Description	Data	Compliance	Description	Data
N/A	Ramp Length (in)	74.0	No	Ramp Slope (%)	10.0
Yes	Ramp Width (in)	68.0	No	Ramp XSlope (%)	2.7
N/A	Flare Type LT	N/A	N/A	Flare Type RT	N/A
N/A	Flare Slope LT (%)	N/A	N/A	Flare Slope RT (%)	N/A
N/A	Flare Traversable LT?	N/A	N/A	Flare Traversable RT?	N/A
N/A	Landing Length (in)	N/A	N/A	DWS Provided?	N/A
N/A	Landing Width (in)	N/A	N/A	DWS Contrast?	N/A
N/A	Landing Slope (%)	N/A	N/A	DWS Length (in)	N/A
N/A	Landing X Slope (%)	N/A	N/A	DWS Full Width?	N/A
N/A	Landing Curb? (Y/N)	N/A	N/A	DWS Offset (in)	N/A
N/A	Shared Landing?	N/A			
N/A	Gutter Ponding?	N/A	N/A	Gutter Slope (%)	N/A
N/A	Gutter Lip Ht (in)	N/A	N/A	Gutter X Slope (%)	N/A
N/A	Painted X Walk1?	No	N/A	Painted X Walk2?	N/A
	X Walk 1 Direction	To NW		X Walk 2 Direction	N/A
N/A	X Walk 1 Width (in)	N/A	N/A	X Walk 2 Width (in)	N/A
	X Walk 1 Slope (%)	7.7		X Walk 2 Slope (%)	N/A
	X Walk 1 X Slope (%)	1.2		X Walk 2 X Slope (%)	N/A

N/A	Ramp inside XWalk1?	N/A	N/A	Ramp inside XWalk2?	N/A
	Road Slope (%)	N/A	N/A	Clear Space?	N/A
	Road X Slope (%)	N/A	N/A	Clear Space to XWalk (in)	N/A
N/A	Any Obstructions?	N/A	N/A	Storm Grate/Utility Hazard?	N/A
	Obstruction Type			Storm Grate/Utility Type	
		N/A			N/A
		No		Surface Condition? (G/P)	Poor

**Remove & Replace Entire Ramp.**
