# Access Compliance Report

## Public Rights-of-Way

### (Curb Ramps)

Intersection ID: 15725	Main Street: CLANTON_RD	Cross Street: S_TRYON_ST	Location: SE
ADA ID: B4AB129853B6	Ramp Type: Perp	Initial Pass/Fail: Fail	Overall Compliance: No
Codes/Mitigation Info/Possible Solution		Field Measurements/Component Compliance	
Severity Score: 13.75

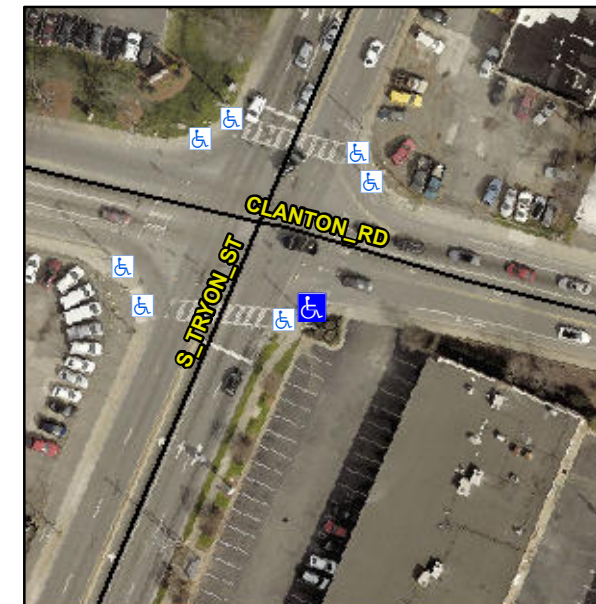
**Not Found, R304.2.2, R304.5.3**

Compliance	Description	Data	Compliance	Description	Data
N/A	Ramp Length (in)	65.0	No	Ramp Slope (%)	9.0
Yes	Ramp Width (in)	48.5	No	Ramp XSlope (%)	2.5
N/A	Flare Type LT	N/A	N/A	Flare Type RT	N/A
N/A	Flare Slope LT (%)	N/A	N/A	Flare Slope RT (%)	N/A
N/A	Flare Traversable LT?	N/A	N/A	Flare Traversable RT?	N/A
N/A	Landing Length (in)	N/A	N/A	DWS Provided?	N/A
N/A	Landing Width (in)	N/A	N/A	DWS Contrast?	N/A
N/A	Landing Slope (%)	N/A	N/A	DWS Length (in)	N/A
N/A	Landing X Slope (%)	N/A	N/A	DWS Full Width?	N/A
N/A	Landing Curb? (Y/N)	N/A	N/A	DWS Offset (in)	N/A
N/A	Shared Landing?	N/A			
N/A	Gutter Ponding?	N/A	N/A	Gutter Slope (%)	N/A
N/A	Gutter Lip Ht (in)	N/A	N/A	Gutter X Slope (%)	N/A
N/A	Painted X Walk1?	Yes	N/A	Painted X Walk2?	N/A
	X Walk 1 Direction	To NE		X Walk 2 Direction	N/A
N/A	X Walk 1 Width (in)	116.0	N/A	X Walk 2 Width (in)	N/A
	X Walk 1 Slope (%)	1.2		X Walk 2 Slope (%)	N/A
	X Walk 1 X Slope (%)	1.4		X Walk 2 X Slope (%)	N/A

N/A	Ramp inside XWalk1?	Yes	N/A	Ramp inside XWalk2?	N/A
	Road Slope (%)	N/A	N/A	Clear Space?	N/A
	Road X Slope (%)	N/A	N/A	Clear Space to XWalk (in)	N/A
N/A	Any Obstructions?	N/A	N/A	Storm Grate/Utility Hazard?	N/A
	Obstruction Type			Storm Grate/Utility Type	
		N/A			N/A
		Yes		Surface Condition? (G/P)	Good

**Remove & Replace Entire Ramp.**
