# Access Compliance Report

## Public Rights-of-Way

### (Curb Ramps)

| Intersection ID: 52336 | Main Street: WOODWARD_AV | Cross Street: KOHLER_AV | Location: | N |

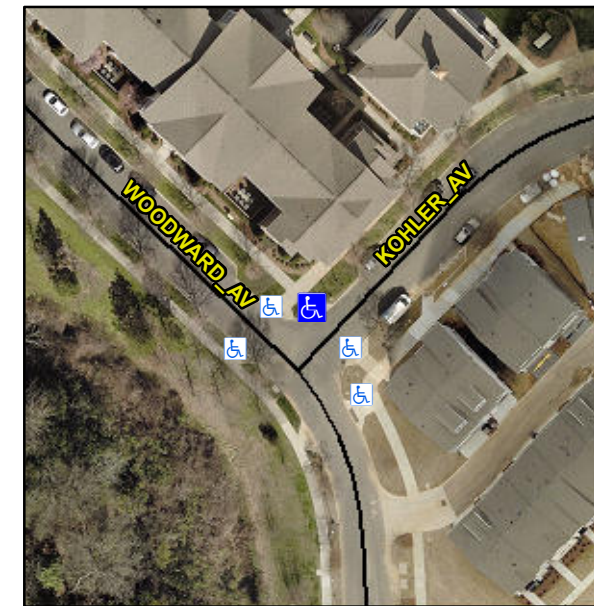
| ADA ID: B4B86DD129AC | Ramp Type: BlendTrans1 | Initial Pass/Fail: Pass | Overall Compliance: No | Severity Score: 7.5 |

**Not Found, R305.1.4, R305.2, R302.7, R302.7.2, R304.5.3**

| Compliance | Description | Data | Compliance | Description | Data |
|---|---|---|---|---|---|
| Yes | Landing Slope (%) | 1.2 | No | DWS Length (in) | 23.5 |
| N/A | Landing Curb? (Y/N) | No | No | DWS Offset (in) | 4.0 |
| No | Gutter Ponding? | Yes | Yes | Gutter Slope (%) | 1.1 |
| No | Gutter Lip Ht (in) | 0.5 | No | Gutter X Slope (%) | 3.8 |
| | | | No | Curb Slope (%) | 20.5 |

**Remove & Replace Curb Ramp With Two New Directional Ramps or Equivalent. Remove & Replace Gutter.**

Total Cost: \$ 3950.00
