# Access Compliance Report

## Public Rights-of-Way

| Intersection ID: 15803 | Main Street: CLANTON_RD | Cross Street: DEWITT_LN | Location: SW |
| ADA ID: B4BB45C930EE | Ramp Type: PerpDiag | Initial Pass/Fail: Fail | Overall Compliance: No |

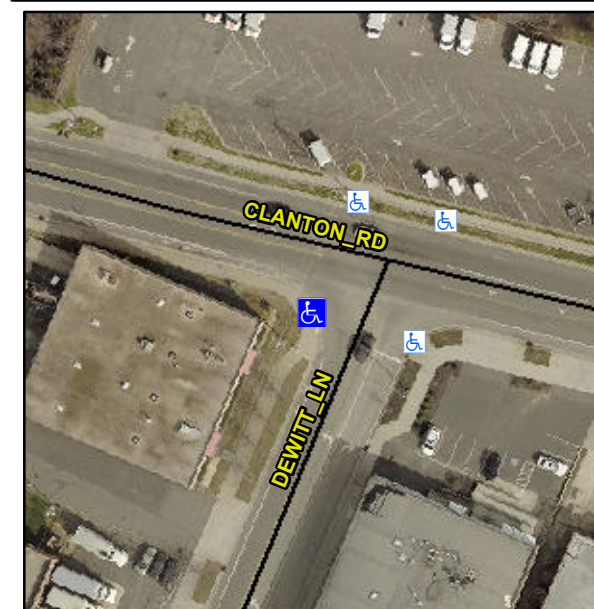
| Severity Score: 8.75 | | | |

**Not Found, R304.5.1**

| Compliance | Description | Data | Compliance | Description | Data |
|---|---|---|---|---|---|
| N/A | Ramp Length (in) | 93.0 | Yes | Ramp Slope (%) | 6.7 |
| No | Ramp Width (in) | 43.0 | Yes | Ramp XSlope (%) | 0.5 |

**Remove & Replace Curb Ramp With Two New Directional Ramps or Equivalent.**

Total Cost: \$ 3200.00
