Access Compliance Report

Public Rights-of-Way

(Curb Ramps)

Intersection ID: 15147	Main Street: QUEENS_RD	Cross Street: EDGEHILL_RD_SOUTH	Location: SW
ADA ID: B4BD6526689E	Ramp Type: Perp	Initial Pass/Fail: Fail	Overall Compliance: No
		Severity Score: 10

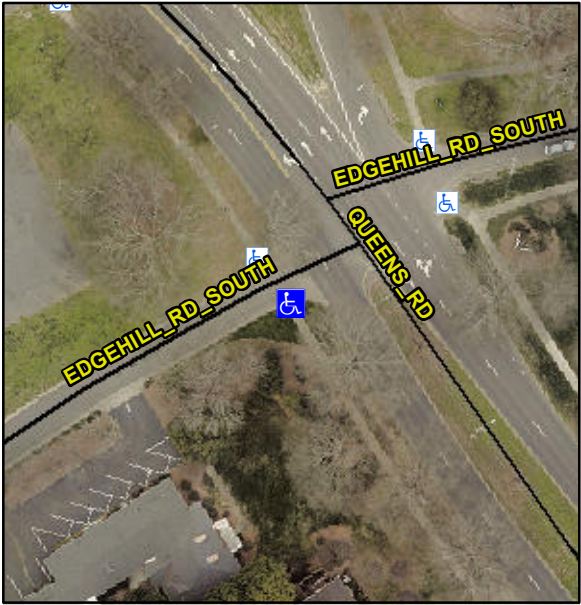
Possible Solutions:		Compliance	Description	Data
	Remove & Replace Entire Ramp.		N/A	Ramp Length (in)	54.0
			No	Ramp Width (in)	36.0
			N/A	Flare Type LT	N/A
			N/A	Flare Slope LT (%)	N/A
			N/A	Flare Traversable LT?	N/A
			N/A	Landing Length (in)	N/A
			N/A	Landing Width (in)	N/A
			N/A	Landing Slope (%)	N/A
			N/A	Landing X Slope (%)	N/A
<p>Surveyor Notes:</p> <p>N/A</p> <p>PROW/ADA:</p> <p>Not Found, R304.5.1, R304.5.3</p>			N/A	Flare Type RT	N/A
			N/A	Flare Slope RT (%)	N/A
			N/A	Flare Traversable RT?	N/A
			N/A	DWS Provided?	N/A
			N/A	DWS Contrast?	N/A
			N/A	DWS Length (in)	N/A
			N/A	DWS Full Width?	N/A
			N/A	DWS Offset (in)	N/A
			N/A	Shared Landing?	N/A
			N/A	Gutter Ponding?	N/A
			N/A	Gutter Lip Ht (in)	N/A
			N/A	Painted X Walk1?	No
				X Walk 1 Direction	To NW
			N/A	X Walk 1 Width (in)	N/A
				X Walk 1 Slope (%)	0.4

X Walk 1 X Slope (%)	1.5
			N/A	Ramp inside XWalk1?	N/A
			N/A	Road Slope (%)	N/A
			N/A	Road X Slope (%)	N/A
			N/A	Any Obstructions?	N/A
Total Cost:		\$ 1850.00		Obstruction Type	
			N/A		N/A
			Yes	Surface Condition? (G/P)	Good
