Access Compliance Report

Public Rights-of-Way

(Curb Ramps)

| Intersection ID: 46697 | Main Street: GOLDFIELDS_DR | Cross Street: COFFEEBERRY_LN | Location: SW |

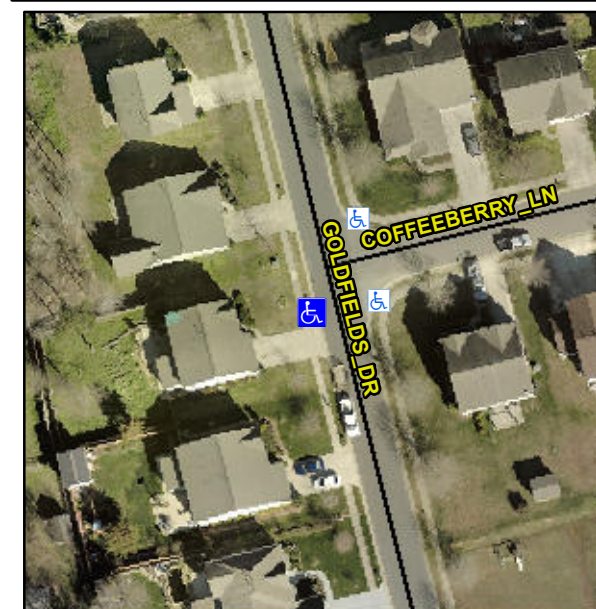
| ADA ID: B4CCBD511013 | Ramp Type: Perp | Initial Pass/Fail: Fail | Overall Compliance: No |

PROW/ADA:

Not Found, R304.2.2

| Compliance | Description | Data | Compliance | Description | Data |
|---|---|---|---|---|---|
| N/A | Ramp Length (in) | 48.0 | No | Ramp Slope (%) | 8.7 |

Possible Solutions:

Remove & Replace Entire Ramp.
