Access Compliance Report

Public Rights-of-Way

(Curb Ramps)

| Intersection ID: 6114 | Main Street: ATKINS_RIDGE_DR | Cross Street: HARTLEY_HILLS_DR | Location: S |

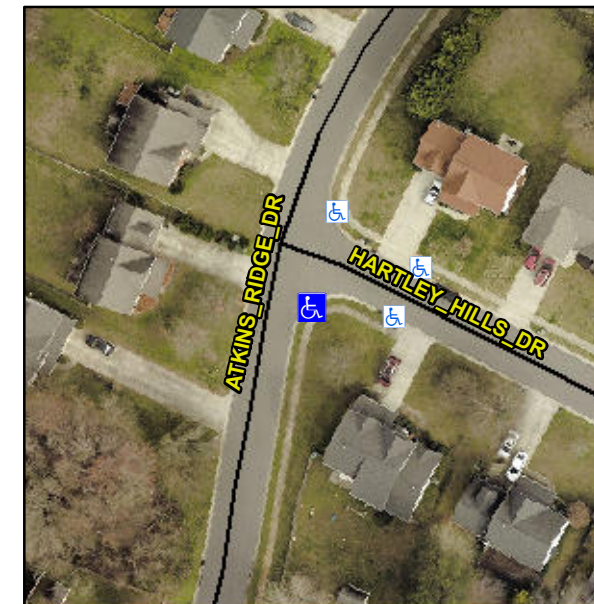
| ADA ID: B4D992012DAD | Ramp Type: Perp | Initial Pass/Fail: Fail | Overall Compliance: No |
| Severity Score: 25 | | | |

R304.2.2, R304.5.3

| Compliance | Description | Data | Compliance | Description | Data |
|---|---|---|---|---|---|
| N/A | Ramp Length (in) | 48.0 | No | Ramp Slope (%) | 10.0 |
| Yes | Ramp Width (in) | 48.0 | No | Ramp XSlope (%) | 6.2 |

Remove & Replace Entire Ramp.

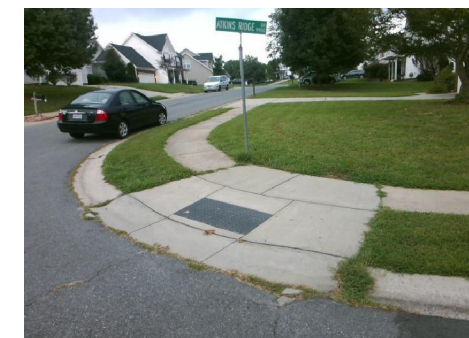
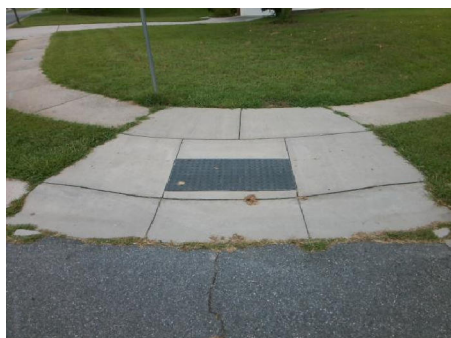
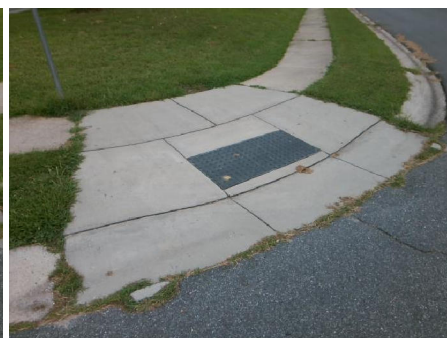
| Compliance | Description | Data | Compliance | Description | Data |
|---|---|---|---|---|---|
| | | | Yes | Surface Condition? (G/P) | Good |
