Access Compliance Report

Public Rights-of-Way

(Curb Ramps)

| Intersection ID: 43482 | Main Street: SAFARI_CT | Cross Street: ERWIN_RD | Location: NE |

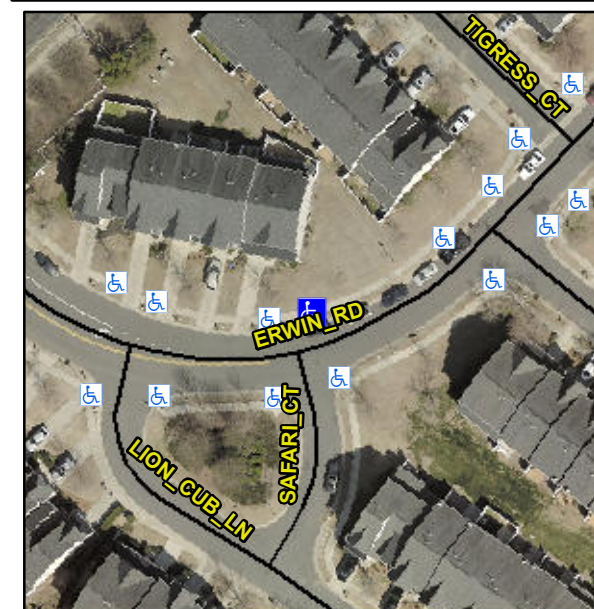
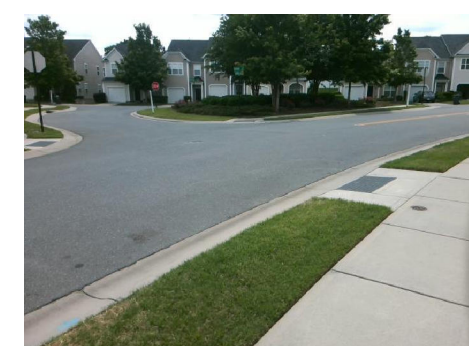
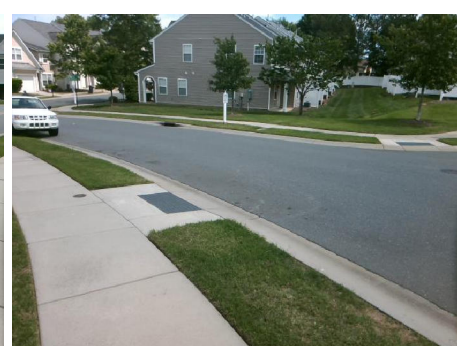
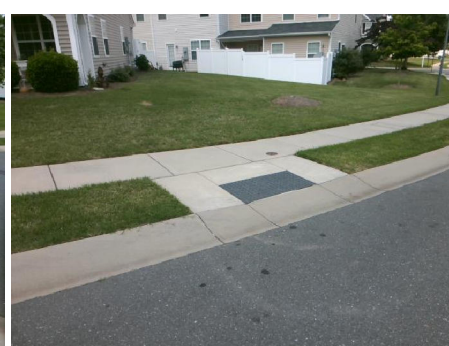
| ADA ID: B4DFA08B511D | Ramp Type: Perp | Initial Pass/Fail: Fail | Overall Compliance: No |

Not Found, R304.2.2, R304.5.3

| Compliance | Description | Data | Compliance | Description | Data |
|---|---|---|---|---|---|
| N/A | Ramp Length (in) | 48.0 | No | Ramp Slope (%) | 9.8 |
| Yes | Ramp Width (in) | 48.0 | No | Ramp XSlope (%) | 5.1 |

Remove & Replace Entire Ramp.
