# Access Compliance Report

## Public Rights-of-Way

### (Curb Ramps)

Intersection ID: 43137	Main Street: N_CHURCH_ST	Cross Street: W_30TH_ST	Location: NE
ADA ID: B4ECEC7996B2	Ramp Type: Perp	Initial Pass/Fail: Fail	Overall Compliance: No
Severity Score: 27.5			
Codes/Mitigation Info/Possible Solution		Field Measurements/Component Compliance

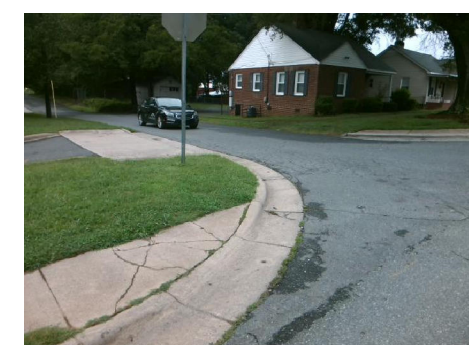
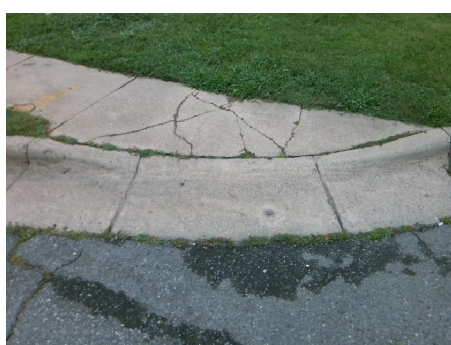
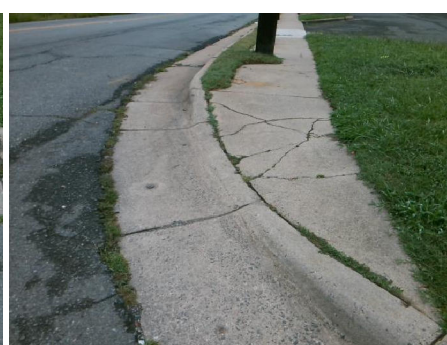
Compliance	Description	Data	Compliance	Description	Data
N/A	Ramp Length (in)	22.5	No	Ramp Slope (%)	8.8
Yes	Ramp Width (in)	48.0	Yes	Ramp XSlope (%)	1.9
N/A	Flare Type LT	N/A	N/A	Flare Type RT	N/A
N/A	Flare Slope LT (%)	N/A	N/A	Flare Slope RT (%)	N/A
N/A	Flare Traversable LT?	N/A	N/A	Flare Traversable RT?	N/A
N/A	Landing Length (in)	N/A	N/A	DWS Provided?	N/A
N/A	Landing Width (in)	N/A	N/A	DWS Contrast?	N/A
N/A	Landing Slope (%)	N/A	N/A	DWS Length (in)	N/A
N/A	Landing X Slope (%)	N/A	N/A	DWS Full Width?	N/A
N/A	Landing Curb? (Y/N)	N/A	N/A	DWS Offset (in)	N/A
N/A	Shared Landing?	N/A			
N/A	Gutter Ponding?	N/A	N/A	Gutter Slope (%)	N/A
N/A	Gutter Lip Ht (in)	1.0	N/A	Gutter X Slope (%)	N/A
N/A	Painted X Walk1?	No	N/A	Painted X Walk2?	N/A
	X Walk 1 Direction	To SE		X Walk 2 Direction	N/A
N/A	X Walk 1 Width (in)	N/A	N/A	X Walk 2 Width (in)	N/A
	X Walk 1 Slope (%)	3.8		X Walk 2 Slope (%)	N/A
	X Walk 1 X Slope (%)	2.7		X Walk 2 X Slope (%)	N/A

N/A	Ramp inside XWalk1?	N/A	N/A	Ramp inside XWalk2?	N/A
	Road Slope (%)	N/A	N/A	Clear Space?	N/A
	Road X Slope (%)	N/A	N/A	Clear Space to XWalk (in)	N/A
N/A	Any Obstructions?	N/A	N/A	Storm Grate/Utility Hazard?	N/A
	Obstruction Type			Storm Grate/Utility Type	
		N/A			N/A
		No		Surface Condition? (G/P)	Poor

**Remove & Replace Entire Ramp.**

**Not Found, R304.2.2, R302.7**
