# Access Compliance Report

## Public Rights-of-Way

### (Curb Ramps)

Intersection ID: 15353	Main Street: DILWORTH_RD_WEST	Cross Street: LEDGEWOOD_LN	Location: S
ADA ID: B4FB500A410A	Ramp Type: Perp	Initial Pass/Fail: Fail	Overall Compliance: No
			Severity Score: 1.25

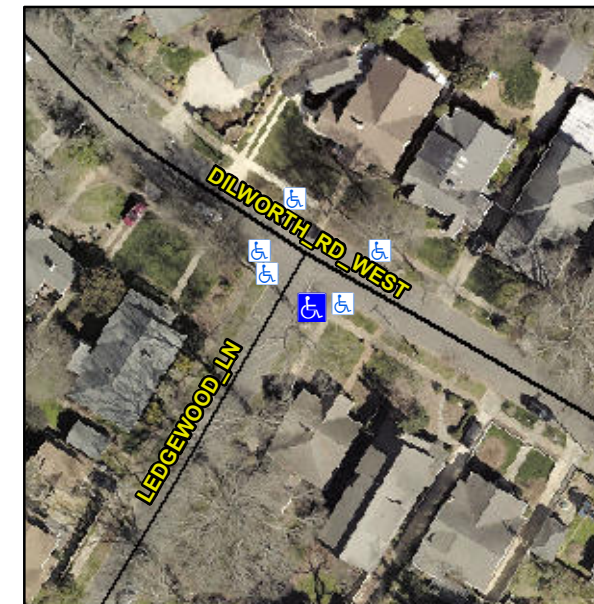
**Not Found, R304.5.3**

Compliance	Description	Data	Compliance	Description	Data
N/A	Ramp Length (in)	90.0	Yes	Ramp Slope (%)	6.1
Yes	Ramp Width (in)	53.0	No	Ramp XSlope (%)	2.3
N/A	Flare Type LT	N/A	N/A	Flare Type RT	N/A
N/A	Flare Slope LT (%)	N/A	N/A	Flare Slope RT (%)	N/A
N/A	Flare Traversable LT?	N/A	N/A	Flare Traversable RT?	N/A
N/A	Landing Length (in)	N/A	N/A	DWS Provided?	N/A
N/A	Landing Width (in)	N/A	N/A	DWS Contrast?	N/A
N/A	Landing Slope (%)	N/A	N/A	DWS Length (in)	N/A
N/A	Landing X Slope (%)	N/A	N/A	DWS Full Width?	N/A
N/A	Landing Curb? (Y/N)	N/A	N/A	DWS Offset (in)	N/A
N/A	Shared Landing?	N/A			
N/A	Gutter Ponding?	N/A	N/A	Gutter Slope (%)	N/A
N/A	Gutter Lip Ht (in)	N/A	N/A	Gutter X Slope (%)	N/A
N/A	Painted X Walk1?	No	N/A	Painted X Walk2?	N/A
	X Walk 1 Direction	To NW		X Walk 2 Direction	N/A
N/A	X Walk 1 Width (in)	N/A	N/A	X Walk 2 Width (in)	N/A
	X Walk 1 Slope (%)	5.9		X Walk 2 Slope (%)	N/A
	X Walk 1 X Slope (%)	1.2		X Walk 2 X Slope (%)	N/A

N/A	Ramp inside XWalk1?	N/A	N/A	Ramp inside XWalk2?	N/A
	Road Slope (%)	N/A	N/A	Clear Space?	N/A
	Road X Slope (%)	N/A	N/A	Clear Space to XWalk (in)	N/A
N/A	Any Obstructions?	N/A	N/A	Storm Grate/Utility Hazard?	N/A
	Obstruction Type			Storm Grate/Utility Type	
		N/A			N/A
			Yes	Surface Condition? (G/P)	Good

**Remove & Replace Entire Ramp.**

Total Cost: \$ 1850.00
