# Access Compliance Report

## Public Rights-of-Way

### (Curb Ramps)

| Intersection ID: 45522 | Main Street: LANSFORD_RD | Cross Street: WILBURN_CT | Location: | W |

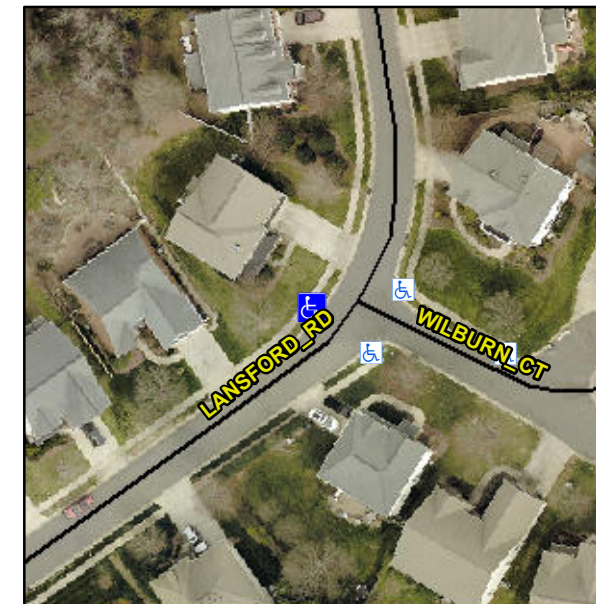
| ADA ID: B4FDB69B5DA5 | Ramp Type: Perp | Initial Pass/Fail: Fail | Overall Compliance: No | Severity Score: 25 |

**R304.5.3**

| Compliance | Description | Data | Compliance | Description | Data |
|---|---|---|---|---|---|
| Yes | Ramp Width (in) | 48.0 | No | Ramp XSlope (%) | 7.0 |

**Remove & Replace Entire Ramp.**

**\$ 1850.00**
