Access Compliance Report

Public Rights-of-Way (Curb Ramps)

Intersection ID: 9425	Main Street: GRIMES_ST	Cross Street: WINSTON_ST	Location: S
ADA ID: B502C56C4B3A	Ramp Type: Combination2	Initial Pass/Fail: Fail	Overall Compliance: No
		Severity Score: 67.5

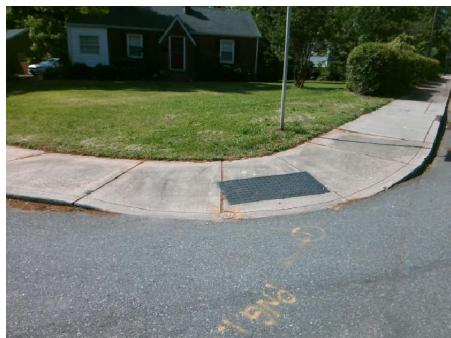
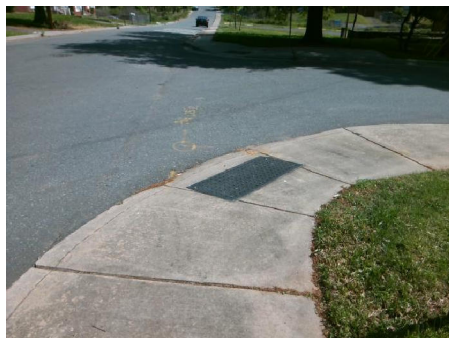
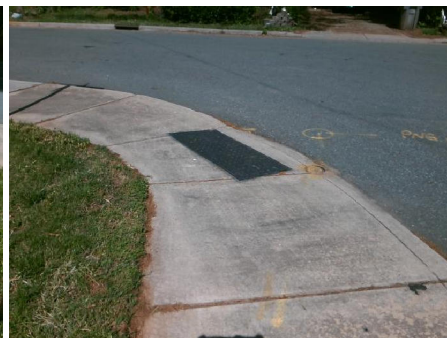
NO CURB LINE, LT RP < 5%

**R304.5.1, R304.2.2, R304.5.3,
R304.3.2**

Compliance	Description	Data	Compliance	Description	Data
N/A	Ramp Length LT (in)	45.0	N/A	Ramp Length RT (in)	37.0
N/A	Ramp Width LT (in)	66.0	Yes	Ramp Width RT (in)	66.0
N/A	Ramp Slope LT (%)	2.2	No	Ramp Slope RT (%)	12.5
N/A	Ramp XSlope LT (%)	7.0	No	Ramp XSlope RT (%)	5.4
N/A	Ramp Length (in)	66.0	No	Ramp Slope (%)	12.4
No	Ramp Width (in)	33.0	No	Ramp XSlope (%)	5.1
N/A	Flare Type LT	N/A	N/A	Flare Type RT	N/A
N/A	Flare Slope LT (%)	N/A	N/A	Flare Slope RT (%)	N/A
N/A	Flare Traversable LT?	N/A	N/A	Flare Traversable RT?	N/A
N/A	Landing Length (in)	N/A	N/A	DWS Provided?	N/A
N/A	Landing Width (in)	N/A	N/A	DWS Contrast?	N/A
N/A	Landing Slope (%)	N/A	N/A	DWS Length (in)	N/A
N/A	Landing X Slope (%)	N/A	N/A	DWS Full Width?	N/A
N/A	Landing Curb? (Y/N)	N/A	N/A	DWS Offset (in)	N/A
N/A	Shared Landing?	N/A			
N/A	Gutter Ponding?	N/A	N/A	Gutter Slope (%)	N/A
N/A	Gutter Lip Ht (in)	N/A	N/A	Gutter X Slope (%)	N/A
N/A	Painted X Walk1?	No	N/A	Painted X Walk2?	N/A

Remove & Replace Entire Ramp.

Total Cost: \$ 1600.00
