Access Compliance Report

Public Rights-of-Way

(Curb Ramps)

Intersection ID: 45249	Main Street: CALDWELL_RD	Cross Street: FARMINGTON_RIDGE_PY	Location: E
ADA ID: B51883ED3818	Ramp Type: Directional1	Initial Pass/Fail: Fail	Overall Compliance: No
Severity Score: 1.25			
Codes/Mitigation Info/Possible Solution		Field Measurements/Component Compliance

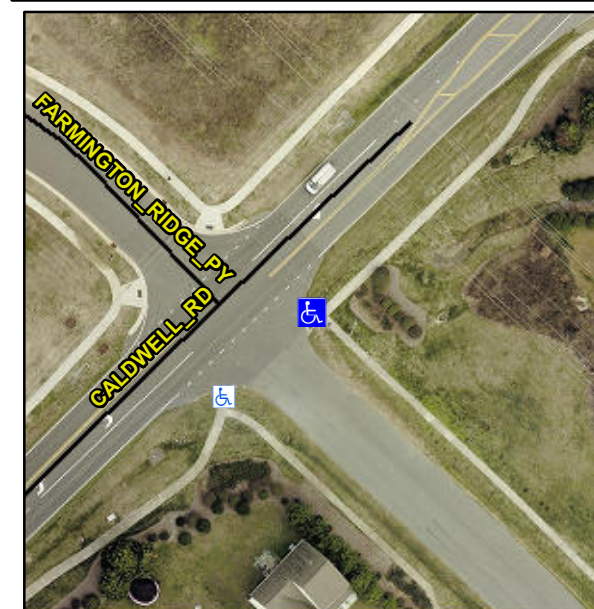
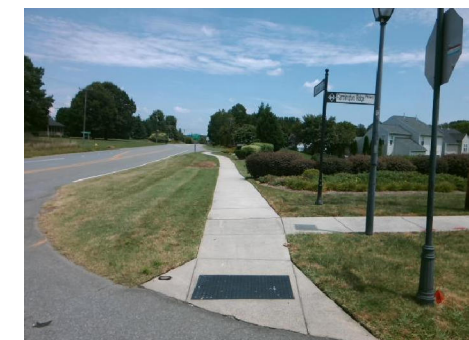
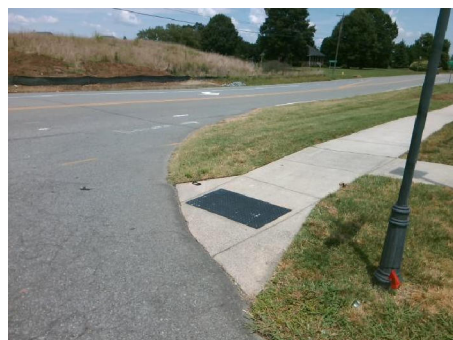
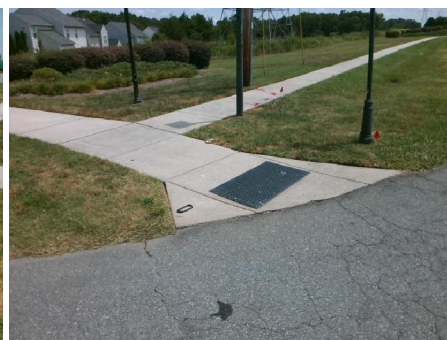
NO CURB

PROW/ADA:

R304.5.3

Compliance	Description	Data	Compliance	Description	Data
N/A	Ramp Length (in)	93.0	N/A	Grade Break?	N/A
Yes	Ramp Width (in)	50.0	N/A	Grade Break Slope (%)	0.0
Yes	Ramp Slope (%)	6.8	N/A	Grade Break XSlope (%)	0.0
No	Ramp XSlope (%)	2.4			
N/A	Flare Type LT	N/A	N/A	Flare Type RT	N/A
N/A	Flare Slope LT (%)	N/A	N/A	Flare Slope RT (%)	0.0
N/A	Flare Traversable LT?	N/A	N/A	Flare Traversable RT?	N/A
N/A	Landing Length (in)	0.0	N/A	DWS Provided?	N/A
N/A	Landing Width (in)	0.0	N/A	DWS Contrast?	N/A
N/A	Landing Slope (%)	0.0	N/A	DWS Length (in)	N/A
N/A	Landing X Slope (%)	0.0	N/A	DWS Full Width?	N/A
N/A	Landing Curb? (Y/N)	N/A	N/A	DWS Offset LT (in)	N/A
N/A	Shared Landing?	N/A	N/A	DWS Offset RT (in)	N/A
N/A	Gutter Ponding?	0.0	N/A	Gutter Slope (%)	N/A
N/A	Gutter Lip Ht (in)	1.0	N/A	Gutter X Slope (%)	N/A
N/A	Painted X Walk1?	No		Road Slope (%)	4.6
	X Walk 1 Direction	To SW		Road X Slope (%)	0.5
	X Walk 1 Width (in)	N/A		Clear Space?	N/A

X Walk 1 Slope (%)	4.6	N/A	Clear Space to XWalk (in)	N/A
	X Walk 1 X Slope (%)	0.5	N/A	Storm Grate/Utility Hazard?	N/A
N/A	Ramp inside XWalk1?	N/A		Storm Grate/Utility Type	
N/A	Any Obstructions?	N/A			N/A
	Obstruction Type		Yes	Surface Condition? (G/P)	Good
			N/A	Curb Slope (%)	N/A

Possible Solutions:

Remove & Replace Entire Ramp.
