Access Compliance Report

Public Rights-of-Way

(Curb Ramps)

Intersection ID: 47611	Main Street: WYALONG_DR	Cross Street: MINTWORTH_AV	Location: NW
ADA ID: B51DCA21AEB9	Ramp Type: Perp	Initial Pass/Fail: Fail	Overall Compliance: No
Severity Score: 13.75			
Codes/Mitigation Info/Possible Solution		Field Measurements/Component Compliance

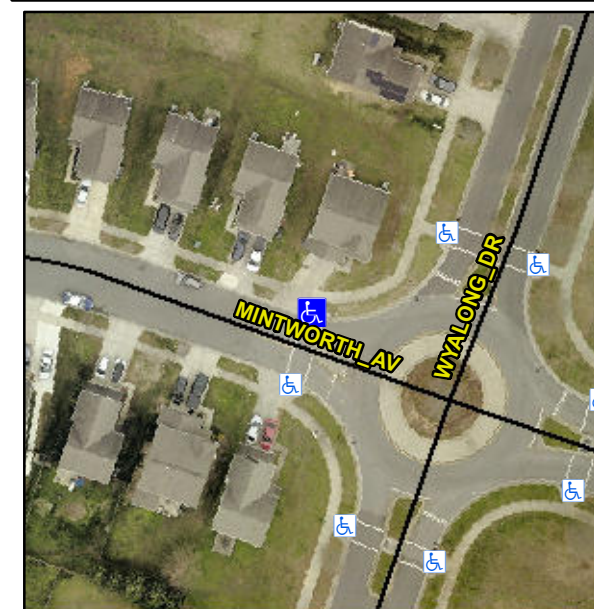
Not Found, R304.2.2, R304.5.3

Compliance	Description	Data	Compliance	Description	Data
N/A	Ramp Length (in)	83.0	No	Ramp Slope (%)	8.6
Yes	Ramp Width (in)	75.0	No	Ramp XSlope (%)	2.5
N/A	Flare Type LT	N/A	N/A	Flare Type RT	N/A
N/A	Flare Slope LT (%)	N/A	N/A	Flare Slope RT (%)	N/A
N/A	Flare Traversable LT?	N/A	N/A	Flare Traversable RT?	N/A
N/A	Landing Length (in)	N/A	N/A	DWS Provided?	N/A
N/A	Landing Width (in)	N/A	N/A	DWS Contrast?	N/A
N/A	Landing Slope (%)	N/A	N/A	DWS Length (in)	N/A
N/A	Landing X Slope (%)	N/A	N/A	DWS Full Width?	N/A
N/A	Landing Curb? (Y/N)	N/A	N/A	DWS Offset (in)	N/A
N/A	Shared Landing?	N/A			
N/A	Gutter Ponding?	N/A	N/A	Gutter Slope (%)	N/A
N/A	Gutter Lip Ht (in)	N/A	N/A	Gutter X Slope (%)	N/A
N/A	Painted X Walk1?	Yes	N/A	Painted X Walk2?	N/A
	X Walk 1 Direction	To SW		X Walk 2 Direction	N/A
N/A	X Walk 1 Width (in)	121.0	N/A	X Walk 2 Width (in)	N/A
	X Walk 1 Slope (%)	5.9		X Walk 2 Slope (%)	N/A
	X Walk 1 X Slope (%)	6.8		X Walk 2 X Slope (%)	N/A

N/A	Ramp inside XWalk1?	Yes	N/A	Ramp inside XWalk2?	N/A
	Road Slope (%)	N/A	N/A	Clear Space?	N/A
	Road X Slope (%)	N/A	N/A	Clear Space to XWalk (in)	N/A
N/A	Any Obstructions?	N/A	N/A	Storm Grate/Utility Hazard?	N/A
	Obstruction Type			Storm Grate/Utility Type	
		N/A			N/A
		Yes		Surface Condition? (G/P)	Good

Possible Solutions:

Remove & Replace Entire Ramp.
