Access Compliance Report

Public Rights-of-Way

(Curb Ramps)

Intersection ID: 1002971	Main Street: CANIPE_FARM_CT	Cross Street: N/A	Location: S
ADA ID: B52F51F9E6C9	Ramp Type: Perp	Initial Pass/Fail: Fail	Overall Compliance: No
Codes/Mitigation Info/Possible Solution		Field Measurements/Component Compliance	
Severity Score: 18.75

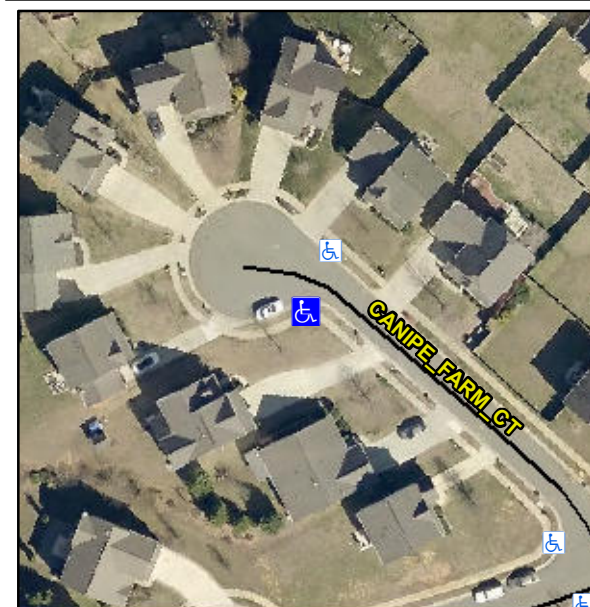
Not Found, R304.5.1

Compliance	Description	Data	Compliance	Description	Data
N/A	Ramp Length (in)	45.0	Yes	Ramp Slope (%)	5.4
No	Ramp Width (in)	35.0	Yes	Ramp XSlope (%)	3.8
N/A	Flare Type LT	N/A	N/A	Flare Type RT	N/A
N/A	Flare Slope LT (%)	N/A	N/A	Flare Slope RT (%)	N/A
N/A	Flare Traversable LT?	N/A	N/A	Flare Traversable RT?	N/A
N/A	Landing Length (in)	N/A	N/A	DWS Provided?	N/A
N/A	Landing Width (in)	N/A	N/A	DWS Contrast?	N/A
N/A	Landing Slope (%)	N/A	N/A	DWS Length (in)	N/A
N/A	Landing X Slope (%)	N/A	N/A	DWS Full Width?	N/A
N/A	Landing Curb? (Y/N)	N/A	N/A	DWS Offset (in)	N/A
N/A	Shared Landing?	N/A			
N/A	Gutter Ponding?	N/A	N/A	Gutter Slope (%)	N/A
N/A	Gutter Lip Ht (in)	N/A	N/A	Gutter X Slope (%)	N/A
N/A	Painted X Walk1?	No	N/A	Painted X Walk2?	N/A
	X Walk 1 Direction	To N		X Walk 2 Direction	N/A
N/A	X Walk 1 Width (in)	N/A	N/A	X Walk 2 Width (in)	N/A
	X Walk 1 Slope (%)	9.0		X Walk 2 Slope (%)	N/A
	X Walk 1 X Slope (%)	4.4		X Walk 2 X Slope (%)	N/A

N/A	Ramp inside XWalk1?	N/A	N/A	Ramp inside XWalk2?	N/A
	Road Slope (%)	N/A	N/A	Clear Space?	N/A
	Road X Slope (%)	N/A	N/A	Clear Space to XWalk (in)	N/A
N/A	Any Obstructions?	N/A	N/A	Storm Grate/Utility Hazard?	N/A
	Obstruction Type			Storm Grate/Utility Type	
		N/A			N/A
			Yes	Surface Condition? (G/P)	Good

Remove & Replace Entire Ramp.
