# Access Compliance Report

## Public Rights-of-Way

### (Curb Ramps)

Intersection ID: 5009	Main Street: OAK_DR	Cross Street: FOX_POINT_DR	Location: NW
ADA ID: B54C25AEA3A0	Ramp Type: PerpDiag	Initial Pass/Fail: Fail	Overall Compliance: No
			Severity Score: 46.25

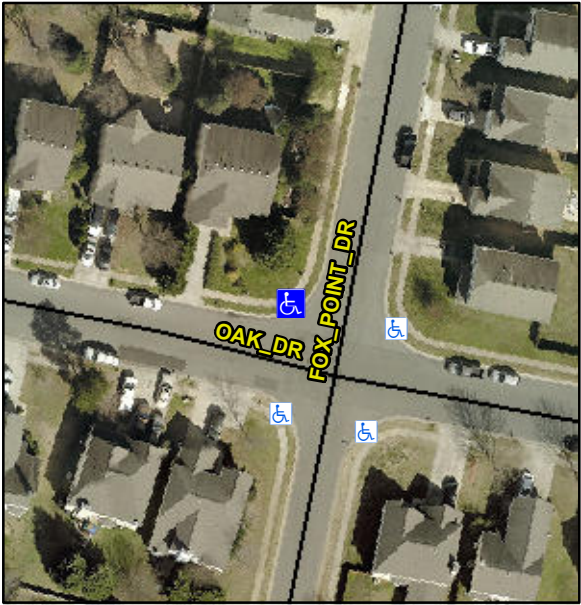
Possible Solutions:		<b>Compliance</b>	<b>Description</b>	<b>Data</b>
	<b>Remove &amp; Replace Curb Ramp With Two New Directional Ramps or Equivalent.</b>		<b>No</b>	Ramp Length (in)	<b>45.0</b>
			<b>No</b>	Ramp Width (in)	<b>42.0</b>
			<b>N/A</b>	Flare Type LT	<b>N/A</b>
			<b>N/A</b>	Flare Slope LT (%)	<b>N/A</b>
			<b>N/A</b>	Flare Traversable LT?	<b>N/A</b>
			<b>N/A</b>	Landing Length (in)	<b>N/A</b>
			<b>N/A</b>	Landing Width (in)	<b>N/A</b>
			<b>N/A</b>	Landing Slope (%)	<b>N/A</b>
			<b>N/A</b>	Landing X Slope (%)	<b>N/A</b>
<p>Surveyor Notes:</p> <p><b>N/A</b></p>			<b>N/A</b>	Landing Curb? (Y/N)	<b>N/A</b>
			<b>N/A</b>	Shared Landing?	<b>N/A</b>
			<b>N/A</b>	Gutter Ponding?	<b>N/A</b>
			<b>N/A</b>	Gutter Lip Ht (in)	<b>N/A</b>
			<b>N/A</b>	Painted X Walk1?	<b>No</b>
				X Walk 1 Direction	<b>To SW</b>

<b>N/A</b>	X Walk 1 Width (in)	<b>N/A</b>
				X Walk 1 Slope (%)	<b>5.8</b>
				X Walk 1 X Slope (%)	<b>8.3</b>
			<b>N/A</b>	Ramp inside XWalk1?	<b>N/A</b>
<p>PROW/ADA:</p> <p><b>R304.5.1, R304.2.2, R304.5.3</b></p>			<b>N/A</b>	Road Slope (%)	<b>6.2</b>
				Road X Slope (%)	<b>1.6</b>
			<b>N/A</b>	Any Obstructions?	<b>N/A</b>
				Obstruction Type	
			<b>N/A</b>		<b>N/A</b>
			<b>Yes</b>	Surface Condition? (G/P)	<b>Good</b>
