Access Compliance Report

Public Rights-of-Way

(Curb Ramps)

Intersection ID: 18204	Main Street: IDLEWILD_RD	Cross Street: OAK_DR	Location:	S
ADA ID: B54D11D63CAE	Ramp Type: BlendTrans1	Initial Pass/Fail: Fail	Overall Compliance: No	Severity Score: 10
Codes/Mitigation Info/Possible Solution		Field Measurements/Component Compliance

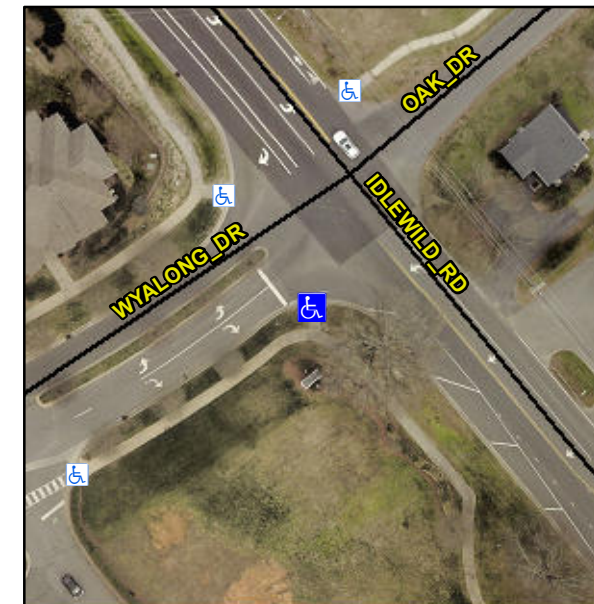
Not Found, R304.5.1, R304.5.3

Compliance	Description	Data	Compliance	Description	Data
N/A	Ramp Length (in)	73.5	Yes	BlendTrans Slope (%)	4.0
No	Ramp Width (in)	45.5	No	BlendTrans XSlope (%)	2.6
N/A	Flare Type LT	N/A	N/A	Flare Type RT	N/A
N/A	Flare Slope LT (%)	N/A	N/A	Flare Slope RT (%)	N/A
N/A	Flare Traversable LT?	N/A	N/A	Flare Traversable RT?	N/A
N/A	Landing Length (in)	N/A	N/A	DWS Provided?	N/A
N/A	Landing Width (in)	N/A	N/A	DWS Contrast?	N/A
N/A	Landing Slope (%)	N/A	N/A	DWS Length (in)	N/A
N/A	Landing X Slope (%)	N/A	N/A	DWS Full Width?	N/A
N/A	Landing Curb? (Y/N)	N/A	N/A	DWS Offset (in)	N/A
N/A	Shared Landing?	N/A			
N/A	Gutter Ponding?	N/A	N/A	Gutter Slope (%)	N/A
N/A	Gutter Lip Ht (in)	N/A	N/A	Gutter X Slope (%)	N/A
N/A	Painted X Walk1?	No	N/A	Painted X Walk2?	No
	X Walk 1 Direction	To NE		X Walk 2 Direction	To NW
	X Walk 1 Width (in)	N/A		X Walk 2 Width (in)	N/A
	X Walk 1 Slope (%)	2.1		X Walk 2 Slope (%)	2.3
	X Walk 1 X Slope (%)	0.9		X Walk 2 X Slope (%)	3.5

N/A	Ramp inside XWalk1?	N/A	N/A	Ramp inside XWalk2?	N/A
	Road Slope (%)	4.2		Clear Space?	N/A
	Road X Slope (%)	2.2	N/A	Clear Space to XWalk (in)	N/A
N/A	Any Obstructions?	N/A	N/A	Storm Grate/Utility Hazard?	N/A
	Obstruction Type			Storm Grate/Utility Type	
		N/A			N/A
			Yes	Surface Condition? (G/P)	Good
			No	Curb Slope (%)	8.6

Remove & Replace Curb Ramp With Two New Directional Ramps or Equivalent.
