# Access Compliance Report

## Public Rights-of-Way

### (Curb Ramps)

Intersection ID: 17448	Main Street: AMBER_CRESTE_LN	Cross Street: CITY_VIEW_DR	Location: NE
ADA ID: B55367EDEBFB	Ramp Type: PerpDiag	Initial Pass/Fail: Fail	Overall Compliance: No
		Severity Score: 22.5

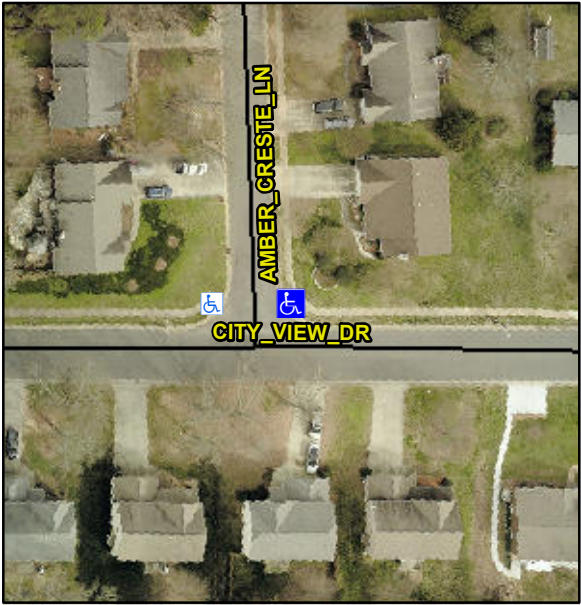
Surveyor Notes:		<b>No</b>	Ramp Length (in)	<b>48.0</b>
	<b>N/A</b>		<b>No</b>	Ramp Width (in)	<b>38.0</b>

PROW/ADA:		<b>N/A</b>	Flare Type LT	<b>N/A</b>
	<b>Not Found, R304.5.1, R304.2.2, R304.5.3</b>		<b>N/A</b>	Flare Slope LT (%)	<b>N/A</b>

Possible Solutions:		<b>Compliance</b>	<b>Description</b>	<b>Data</b>
	<b>Remove &amp; Replace Curb Ramp With Two New Directional Ramps or Equivalent.</b>		<b>Compliance</b>	<b>Description</b>	<b>Data</b>
