Access Compliance Report

Public Rights-of-Way

(Curb Ramps)

Intersection ID: 45787	Main Street: COPPER_TOP_CT	Cross Street: LONG_HILL_DR	Location: SW
ADA ID: B554E9FE5465	Ramp Type: Perp	Initial Pass/Fail: Fail	Overall Compliance: No
Codes/Mitigation Info/Possible Solution		Field Measurements/Component Compliance	
Severity Score: 21.25

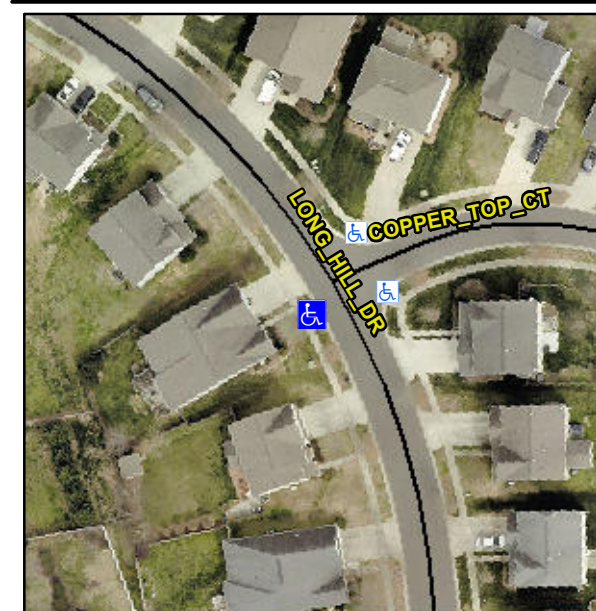
Not Found, R304.5.1, R304.5.3

Compliance	Description	Data	Compliance	Description	Data
N/A	Ramp Length (in)	70.5	Yes	Ramp Slope (%)	5.6
No	Ramp Width (in)	47.0	No	Ramp XSlope (%)	6.6
N/A	Flare Type LT	N/A	N/A	Flare Type RT	N/A
N/A	Flare Slope LT (%)	N/A	N/A	Flare Slope RT (%)	N/A
N/A	Flare Traversable LT?	N/A	N/A	Flare Traversable RT?	N/A
N/A	Landing Length (in)	N/A	N/A	DWS Provided?	N/A
N/A	Landing Width (in)	N/A	N/A	DWS Contrast?	N/A
N/A	Landing Slope (%)	N/A	N/A	DWS Length (in)	N/A
N/A	Landing X Slope (%)	N/A	N/A	DWS Full Width?	N/A
N/A	Landing Curb? (Y/N)	N/A	N/A	DWS Offset (in)	N/A
N/A	Shared Landing?	N/A			
N/A	Gutter Ponding?	N/A	N/A	Gutter Slope (%)	N/A
N/A	Gutter Lip Ht (in)	N/A	N/A	Gutter X Slope (%)	N/A
N/A	Painted X Walk1?	No	N/A	Painted X Walk2?	N/A
	X Walk 1 Direction	To E		X Walk 2 Direction	N/A
N/A	X Walk 1 Width (in)	N/A	N/A	X Walk 2 Width (in)	N/A
	X Walk 1 Slope (%)	3.0		X Walk 2 Slope (%)	N/A
	X Walk 1 X Slope (%)	4.2		X Walk 2 X Slope (%)	N/A

N/A	Ramp inside XWalk1?	N/A	N/A	Ramp inside XWalk2?	N/A
	Road Slope (%)	N/A	N/A	Clear Space?	N/A
	Road X Slope (%)	N/A	N/A	Clear Space to XWalk (in)	N/A
N/A	Any Obstructions?	N/A	N/A	Storm Grate/Utility Hazard?	N/A
	Obstruction Type			Storm Grate/Utility Type	
		N/A			N/A
			Yes	Surface Condition? (G/P)	Good

Possible Solutions:

Remove & Replace Entire Ramp.
