## **Access Compliance Report Public Rights-of-Way** (Curb Ramps)

Main Street: PANOS DR Cross Street: W W T HARRIS BV Location: Intersection ID: 29966 NE ADA ID: B558F10C2B60 Ramp Type: Perp Initial Pass/Fail: Fail **Overall Compliance: No** 10 **Severity Score:**

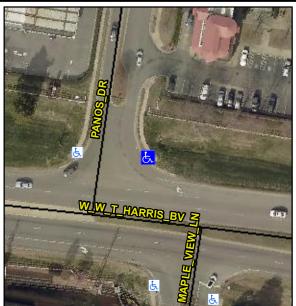
71 COCIDIO COIGNICII		i iola ilioadal c	//////////////////////////////////////	<u> </u>	tonic Gonnphanico
Possible Solutions:	Comp	liance Description	Data	Compl	liance Description
Remove & Replace Entire Ramp.	N/A	Ramp Length (in)	49.0	Yes	Ramp Slope (%)
	No	Ramp Width (in)	45.0	No	Ramp XSlope (%)
	N/A	Flare Type LT	N/A	N/A	Flare Type RT
	N/A	Flare Slope LT (%)	N/A	N/A	Flare Slope RT (%)
	N/A	Flare Traversable LT?	N/A	N/A	Flare Traversable R
	N/A	Landing Length (in)	N/A	N/A	DWS Provided?
Surveyor Notes:	N/A	Landing Width (in)	N/A	N/A	DWS Contrast?
N/A	N/A	Landing Slope (%)	N/A	N/A	DWS Length (in)
	N/A	Landing X Slope (%)	N/A	N/A	DWS Full Width?
	N/A	Landing Curb? (Y/N)	N/A	N/A	DWS Offset (in)
	N/A	Shared Landing?	N/A		,
PROW/ADA:	N/A	Gutter Ponding?	N/A	N/A	Gutter Slope (%)
R304.5.1, R304.5.3	N/A	Gutter Lip Ht (in)	N/A	N/A	Gutter X Slope (%)
1,1,1,1,004.0.0	N/A	Painted X Walk1?	No	N/A	Painted X Walk2?
		X Walk 1 Direction	To W		X Walk 2 Direction
