Access Compliance Report Public Rights-of-Way (Curb Ramps)

Intersection ID: 14552 Main Street: BAXTER_ST **Cross Street: AVANT_ST** Location: NW **Overall Compliance: No** ADA ID: B55A7A33B75F Ramp Type: PerpDiag Initial Pass/Fail: Fail **Severity Score:** 10

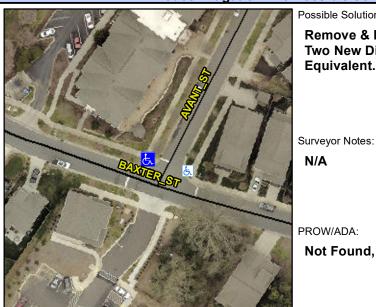
Not Found, R304.5.1, R304.5.3

Field Measurements/Component Compliance					
Compliance Description		Data	Compliance Description		Data
N/A	Ramp Length (in)	64.0	Yes	Ramp Slope (%)	8.3
No	Ramp Width (in)	46.0	No	Ramp XSlope (%)	3.2
N/A	Flare Type LT	N/A	N/A	Flare Type RT	N/A
N/A	Flare Slope LT (%)	N/A	N/A	Flare Slope RT (%)	N/A
N/A	Flare Traversable LT?	N/A	N/A	Flare Traversable RT?	N/A
N/A	Landing Length (in)	N/A	N/A	DWS Provided?	N/A
N/A	Landing Width (in)	N/A	N/A	DWS Contrast?	N/A
N/A	Landing Slope (%)	N/A	N/A	DWS Length (in)	N/A
N/A	Landing X Slope (%)	N/A	N/A	DWS Full Width?	N/A
N/A	Landing Curb? (Y/N)	N/A	N/A	DWS Offset (in)	N/A
N/A	Shared Landing?	N/A			
N/A	Gutter Ponding?	N/A	N/A	Gutter Slope (%)	N/A
N/A	Gutter Lip Ht (in)	N/A	N/A	Gutter X Slope (%)	N/A
N/A	Painted X Walk1?	No	N/A	Painted X Walk2?	No
	X Walk 1 Direction	To S		X Walk 2 Direction	To SE
N/A	X Walk 1 Width (in)	N/A	N/A	X Walk 2 Width (in)	N/A
	X Walk 1 Slope (%)	3.4		X Walk 2 Slope (%)	1.1

X Walk 1 X Slope (%)	0.4		X Walk 2 X Slope (%)	1.6
N/A	Ramp inside XWalk1?	N/A	N/A	Ramp inside XWalk2?	N/A
	Road Slope (%)	0.2	N/A	Clear Space?	N/A
	Road X Slope (%)	1.6	N/A	Clear Space to XWalk (in)	N/A
N/A	Any Obstructions?	N/A	N/A	Storm Grate/Utility Hazard?	N/A
	Obstruction Type		l	Storm Grate/Utility Type	
		N/A			N/A
			Yes	Surface Condition? (G/P)	Good

BAXTER ST Street 1 Name Stop Condition-Street 2 Street 2 Name **AVANT ST** Stop Condition-Street 1 StopSign Remove & Replace Curb Ramp With **Two New Directional Ramps or** Equivalent.
