Access Compliance Report

Public Rights-of-Way

(Curb Ramps)

Intersection ID: 31581	Main Street: BLYTHEDALE_DR	Cross Street: PATTONSBURG_DR	Location: NE
ADA ID: B55E0E34FBEC	Ramp Type: PerpDiag	Initial Pass/Fail: Fail	Overall Compliance: No
Severity Score: 8.75			
Codes/Mitigation Info/Possible Solution		Field Measurements/Component Compliance

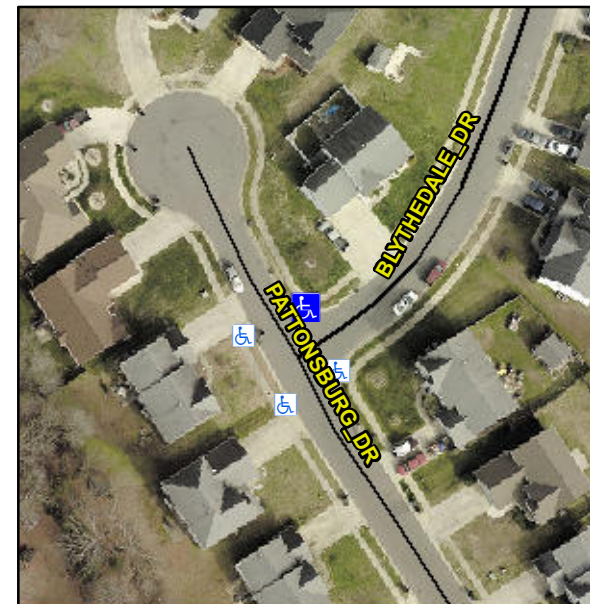
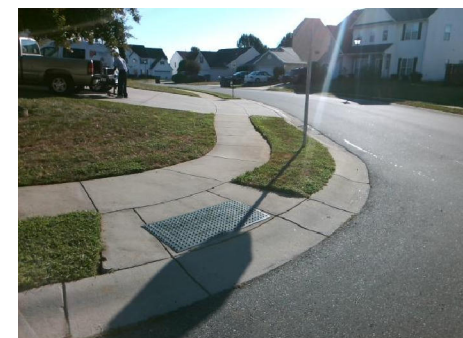
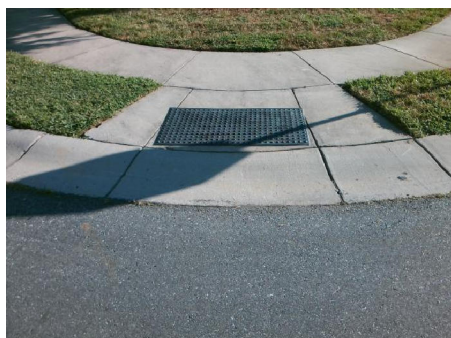
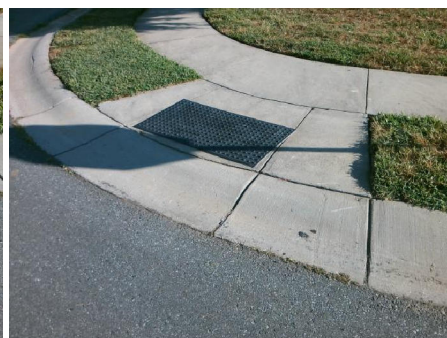
Not Found, R304.5.1

Compliance	Description	Data	Compliance	Description	Data
N/A	Ramp Length (in)	45.0	Yes	Ramp Slope (%)	5.2
No	Ramp Width (in)	40.0	Yes	Ramp XSlope (%)	0.3
N/A	Flare Type LT	N/A	N/A	Flare Type RT	N/A
N/A	Flare Slope LT (%)	N/A	N/A	Flare Slope RT (%)	N/A
N/A	Flare Traversable LT?	N/A	N/A	Flare Traversable RT?	N/A
N/A	Landing Length (in)	N/A	N/A	DWS Provided?	N/A
N/A	Landing Width (in)	N/A	N/A	DWS Contrast?	N/A
N/A	Landing Slope (%)	N/A	N/A	DWS Length (in)	N/A
N/A	Landing X Slope (%)	N/A	N/A	DWS Full Width?	N/A
N/A	Landing Curb? (Y/N)	N/A	N/A	DWS Offset (in)	N/A
N/A	Shared Landing?	N/A			
N/A	Gutter Ponding?	N/A	N/A	Gutter Slope (%)	N/A
N/A	Gutter Lip Ht (in)	N/A	N/A	Gutter X Slope (%)	N/A
N/A	Painted X Walk1?	No	N/A	Painted X Walk2?	No
	X Walk 1 Direction	To W		X Walk 2 Direction	To S
N/A	X Walk 1 Width (in)	N/A	N/A	X Walk 2 Width (in)	N/A
	X Walk 1 Slope (%)	4.5		X Walk 2 Slope (%)	2.2
	X Walk 1 X Slope (%)	1.0		X Walk 2 X Slope (%)	2.3

N/A	Ramp inside XWalk1?	N/A	N/A	Ramp inside XWalk2?	N/A
	Road Slope (%)	0.8	N/A	Clear Space?	N/A
	Road X Slope (%)	3.3	N/A	Clear Space to XWalk (in)	N/A
N/A	Any Obstructions?	N/A	N/A	Storm Grate/Utility Hazard?	N/A
	Obstruction Type			Storm Grate/Utility Type	
		N/A			N/A
		Yes		Surface Condition? (G/P)	Good

Remove & Replace Curb Ramp With Two New Directional Ramps or Equivalent.

Total Cost: \$ 3200.00
