# Access Compliance Report

## Public Rights-of-Way

| Intersection ID: 7422 | Main Street: BOXMEER_DR | Cross Street: STATESVILLE_RD | Location: NW |
| ADA ID: B56E9ACA85B3 | Ramp Type: Perp | Initial Pass/Fail: Fail | Overall Compliance: No |

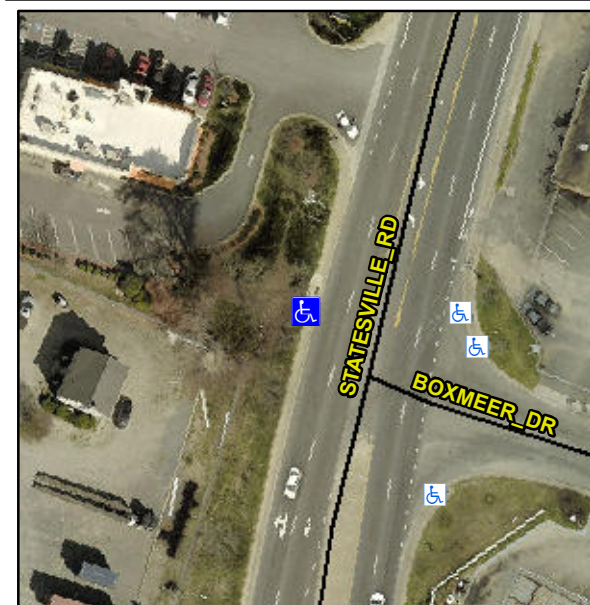
| Severity Score: 36.25 | | | |

**Not Found, R304.5.1, R304.2.2, R302.7**

| Compliance | Description | Data | Compliance | Description | Data |
|---|---|---|---|---|---|
| N/A | Ramp Length (in) | 60.0 | No | Ramp Slope (%) | 10.7 |
| No | Ramp Width (in) | 36.0 | Yes | Ramp XSlope (%) | 0.8 |
| | | No | | Surface Condition? (G/P) | Poor |

**Remove & Replace Entire Ramp.**

Total Cost: \$ 1850.00
