# Access Compliance Report

## Public Rights-of-Way

| Intersection ID: 44754 | Main Street: LENOX_POINTE_DR | Cross Street: PIONEER_AV | Location: NE |
| ADA ID: B5726CEAE8E8 | Ramp Type: PerpDiag | Initial Pass/Fail: Fail | Overall Compliance: No |

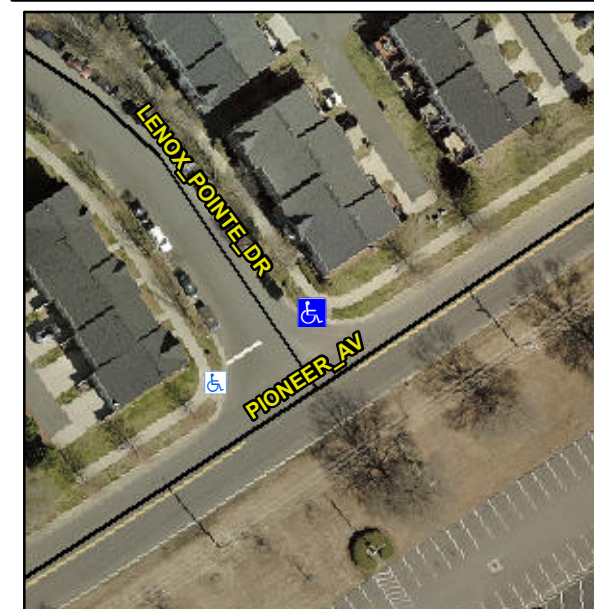
**Not Found, R304.5.1, R304.2.2, R304.5.3**

| Compliance | Description | Data | Compliance | Description | Data |
|---|---|---|---|---|---|
| N/A | Ramp Length (in) | 78.0 | No | Ramp Slope (%) | 11.2 |
| No | Ramp Width (in) | 47.0 | No | Ramp XSlope (%) | 2.3 |

**Remove & Replace Curb Ramp With Two New Directional Ramps or Equivalent.**
