Access Compliance Report

Public Rights-of-Way

(Curb Ramps)

Intersection ID: 45167	Main Street: ARAGORN_LN	Cross Street: STRIDER_DR	Location:	N
ADA ID: B57413FEB8ED	Ramp Type: BlendTrans1	Initial Pass/Fail: Fail	Overall Compliance: No	Severity Score: 17.5
Codes/Mitigation Info/Possible Solution		Field Measurements/Component Compliance

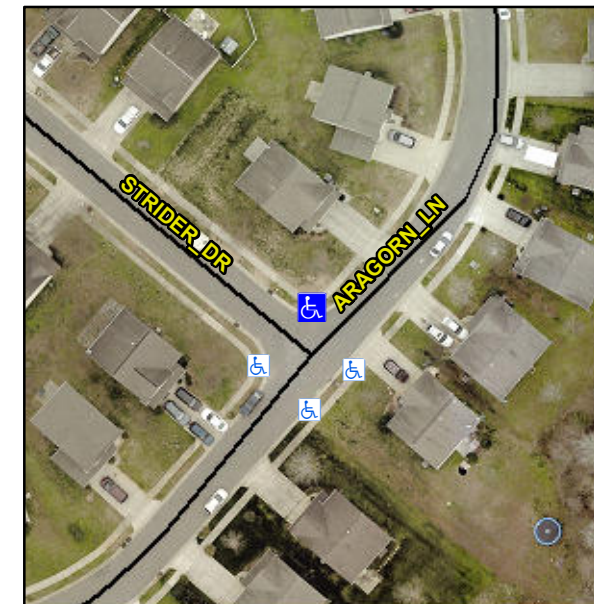
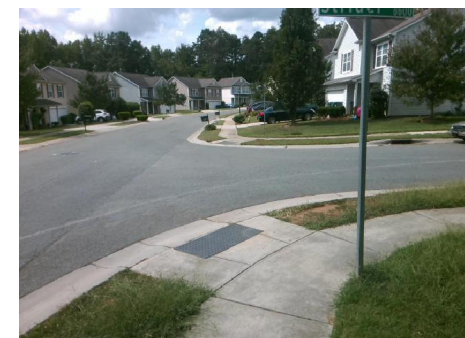
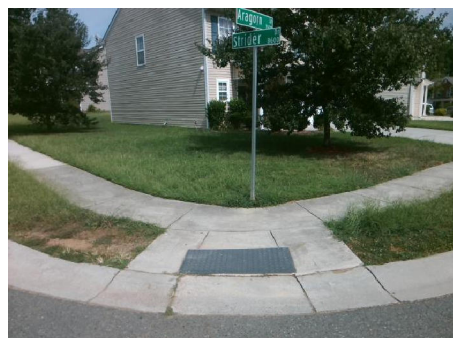
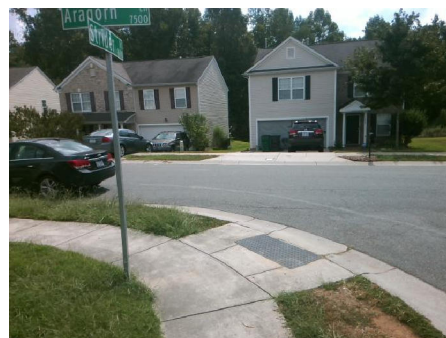
Not Found, R304.5.1

Compliance	Description	Data	Compliance	Description	Data
N/A	Ramp Length (in)	48.0	Yes	BlendTrans Slope (%)	4.3
No	Ramp Width (in)	33.0	Yes	BlendTrans XSlope (%)	1.4
N/A	Flare Type LT	N/A	N/A	Flare Type RT	N/A
N/A	Flare Slope LT (%)	N/A	N/A	Flare Slope RT (%)	N/A
N/A	Flare Traversable LT?	N/A	N/A	Flare Traversable RT?	N/A
N/A	Landing Length (in)	N/A	N/A	DWS Provided?	N/A
N/A	Landing Width (in)	N/A	N/A	DWS Contrast?	N/A
N/A	Landing Slope (%)	N/A	N/A	DWS Length (in)	N/A
N/A	Landing X Slope (%)	N/A	N/A	DWS Full Width?	N/A
N/A	Landing Curb? (Y/N)	N/A	N/A	DWS Offset (in)	N/A
N/A	Shared Landing?	N/A			
N/A	Gutter Ponding?	N/A	N/A	Gutter Slope (%)	N/A
N/A	Gutter Lip Ht (in)	N/A	N/A	Gutter X Slope (%)	N/A
N/A	Painted X Walk1?	No	N/A	Painted X Walk2?	No
	X Walk 1 Direction	To SW		X Walk 2 Direction	To SE
	X Walk 1 Width (in)	N/A		X Walk 2 Width (in)	N/A
	X Walk 1 Slope (%)	3.5		X Walk 2 Slope (%)	1.9
	X Walk 1 X Slope (%)	2.6		X Walk 2 X Slope (%)	1.4

N/A	Ramp inside XWalk1?	N/A	N/A	Ramp inside XWalk2?	N/A
	Road Slope (%)	0.0		Clear Space?	N/A
	Road X Slope (%)	0.5	N/A	Clear Space to XWalk (in)	N/A
N/A	Any Obstructions?	N/A	N/A	Storm Grate/Utility Hazard?	N/A
	Obstruction Type			Storm Grate/Utility Type	
		N/A			N/A
			Yes	Surface Condition? (G/P)	Good
			No	Curb Slope (%)	14.9

Remove & Replace Curb Ramp With Two New Directional Ramps or Equivalent.
