## **Access Compliance Report Public Rights-of-Way** (Curb Ramps)

Intersection ID: 26586 Main Street: ARBORHILL RD **Cross Street: WINTHORP RIDGE RD** Location: ADA ID: B577A0B4F207 Ramp Type: PerpDiag Initial Pass/Fail: Fail **Overall Compliance: No** Severity Score: 13.75

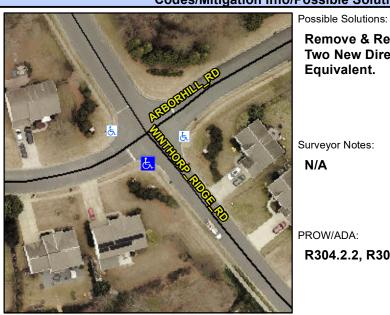
R304.2.2, R304.5.3

| Field Measurements/Component Compliance | | | | | |
|---|---|---|---|---|---|
| N/A | Ramp Length (in) | 49.0 | No | Ramp Slope (%) | 8.4 |
| Yes | Ramp Width (in) | 48.0 | No | Ramp XSlope (%) | 3.0 |

WINTHORP RIDGE RD Street 1 Name Stop Condition-Street 2 StopSign Street 2 Name **ARBORHILL RD** Stop Condition-Street 1 StopSign Remove & Replace Curb Ramp With **Two New Directional Ramps or** Equivalent.
