# Access Compliance Report

## Public Rights-of-Way

### (Curb Ramps)

Intersection ID: 30441	Main Street: ELM_BEND_DR	Cross Street: CADENCE_CT	Location: NW
ADA ID: B58268538D45	Ramp Type: PerpDiag	Initial Pass/Fail: Fail	Overall Compliance: No
Severity Score: 10			
Codes/Mitigation Info/Possible Solution		Field Measurements/Component Compliance

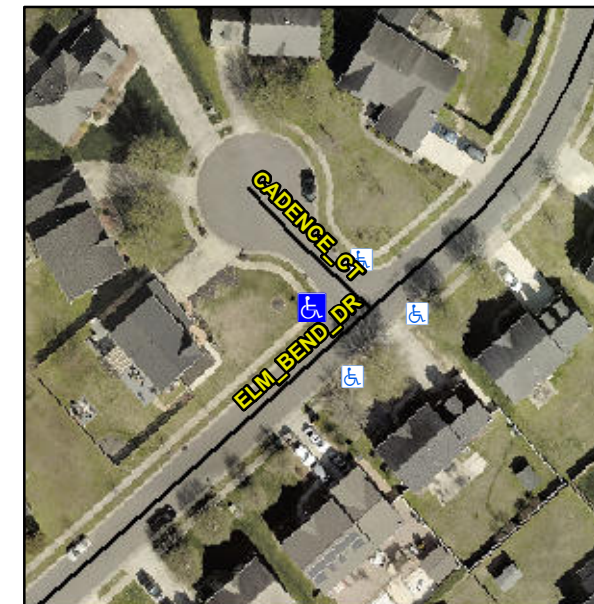
Compliance	Description	Data	Compliance	Description	Data
N/A	Ramp Length (in)	46.0	Yes	Ramp Slope (%)	7.4
No	Ramp Width (in)	46.5	No	Ramp XSlope (%)	2.3
N/A	Flare Type LT	N/A	N/A	Flare Type RT	N/A
N/A	Flare Slope LT (%)	N/A	N/A	Flare Slope RT (%)	N/A
N/A	Flare Traversable LT?	N/A	N/A	Flare Traversable RT?	N/A
N/A	Landing Length (in)	N/A	N/A	DWS Provided?	N/A
N/A	Landing Width (in)	N/A	N/A	DWS Contrast?	N/A
N/A	Landing Slope (%)	N/A	N/A	DWS Length (in)	N/A
N/A	Landing X Slope (%)	N/A	N/A	DWS Full Width?	N/A
N/A	Landing Curb? (Y/N)	N/A	N/A	DWS Offset (in)	N/A
N/A	Shared Landing?	N/A			
N/A	Gutter Ponding?	N/A	N/A	Gutter Slope (%)	N/A
N/A	Gutter Lip Ht (in)	N/A	N/A	Gutter X Slope (%)	N/A
N/A	Painted X Walk1?	No	N/A	Painted X Walk2?	No
	X Walk 1 Direction	To SE		X Walk 2 Direction	To NE
N/A	X Walk 1 Width (in)	N/A	N/A	X Walk 2 Width (in)	N/A
	X Walk 1 Slope (%)	3.5		X Walk 2 Slope (%)	1.9
	X Walk 1 X Slope (%)	1.3		X Walk 2 X Slope (%)	2.0

N/A	Ramp inside XWalk1?	N/A	N/A	Ramp inside XWalk2?	N/A
	Road Slope (%)	0.3	N/A	Clear Space?	N/A
	Road X Slope (%)	3.5	N/A	Clear Space to XWalk (in)	N/A
N/A	Any Obstructions?	N/A	N/A	Storm Grate/Utility Hazard?	N/A
	Obstruction Type			Storm Grate/Utility Type	
		N/A			N/A
			Yes	Surface Condition? (G/P)	Good

Possible Solutions:

**Remove & Replace Curb Ramp With Two New Directional Ramps or Equivalent.**

**R304.5.1, R304.5.3**

Total Cost: \$ 3200.00
