# Access Compliance Report

## Public Rights-of-Way

Intersection ID: 13647	Main Street: CLAYMONT_DR	Cross Street: SCHUBERT_PL	Location: SE
ADA ID: B587027A16F3	Ramp Type: BlendTrans1	Initial Pass/Fail: Fail	Overall Compliance: No
Severity Score: 8.75			
Codes/Mitigation Info/Possible Solution		Field Measurements/Component Compliance

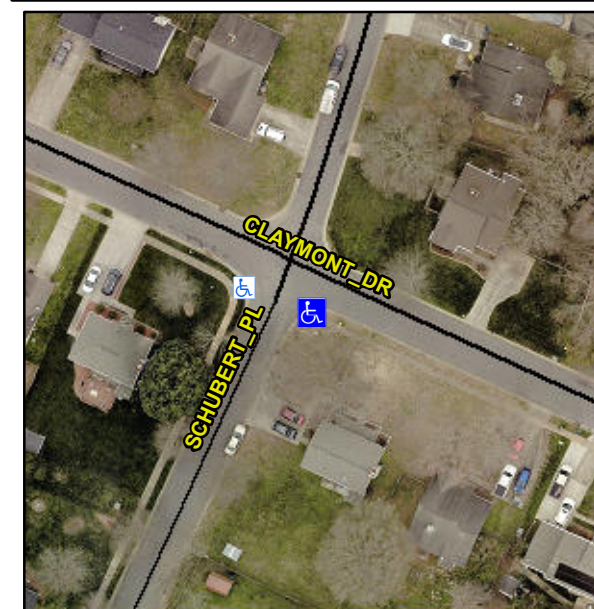
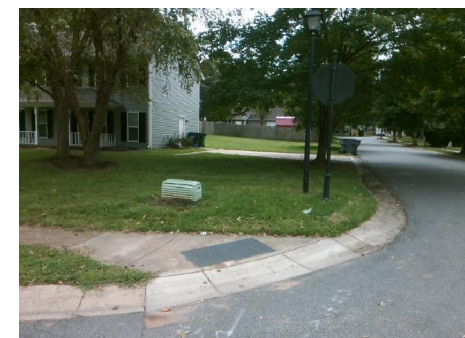
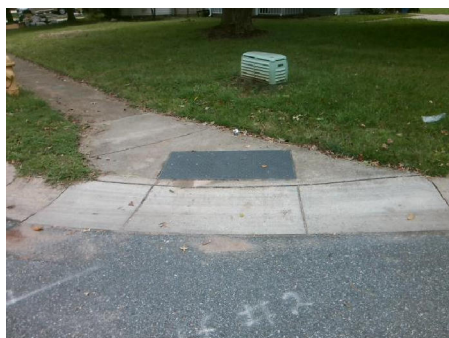
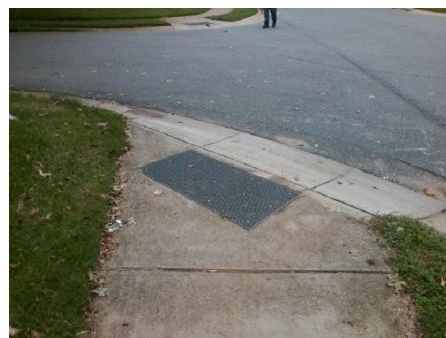
**Not Found, R304.5.1**

Compliance	Description	Data	Compliance	Description	Data
N/A	Ramp Length (in)	46.0	Yes	BlendTrans Slope (%)	3.5
No	Ramp Width (in)	47.5	Yes	BlendTrans XSlope (%)	1.8
N/A	Flare Type LT	N/A	N/A	Flare Type RT	N/A
N/A	Flare Slope LT (%)	N/A	N/A	Flare Slope RT (%)	N/A
N/A	Flare Traversable LT?	N/A	N/A	Flare Traversable RT?	N/A
N/A	Landing Length (in)	N/A	N/A	DWS Provided?	N/A
N/A	Landing Width (in)	N/A	N/A	DWS Contrast?	N/A
N/A	Landing Slope (%)	N/A	N/A	DWS Length (in)	N/A
N/A	Landing X Slope (%)	N/A	N/A	DWS Full Width?	N/A
N/A	Landing Curb? (Y/N)	N/A	N/A	DWS Offset (in)	N/A
N/A	Shared Landing?	N/A			
N/A	Gutter Ponding?	N/A	N/A	Gutter Slope (%)	N/A
N/A	Gutter Lip Ht (in)	N/A	N/A	Gutter X Slope (%)	N/A
N/A	Painted X Walk1?	No	N/A	Painted X Walk2?	N/A
	X Walk 1 Direction	To NW		X Walk 2 Direction	N/A
	X Walk 1 Width (in)	N/A		X Walk 2 Width (in)	N/A
	X Walk 1 Slope (%)	3.4		X Walk 2 Slope (%)	N/A
	X Walk 1 X Slope (%)	1.5		X Walk 2 X Slope (%)	N/A

N/A	Ramp inside XWalk1?	N/A	N/A	Ramp inside XWalk2?	N/A
	Road Slope (%)	1.5		Clear Space?	N/A
	Road X Slope (%)	3.4	N/A	Clear Space to XWalk (in)	N/A
N/A	Any Obstructions?	N/A	N/A	Storm Grate/Utility Hazard?	N/A
	Obstruction Type			Storm Grate/Utility Type	
		N/A			N/A
			Yes	Surface Condition? (G/P)	Good
			No	Curb Slope (%)	8.1

**Remove & Replace Curb Ramp With Two New Directional Ramps or Equivalent.**

Total Cost: \$ 3200.00
