Access Compliance Report Public Rights-of-Way (Curb Ramps)

Intersection ID: 18210Main Street:E_WOODLAWN_RDCross Street:BRANDYWINE_RDLocation:NEADA ID: B58782CC7AF8Ramp Type:MedianPerpInitial Pass/Fail:FailOverall Compliance:NoSeverity Score:25

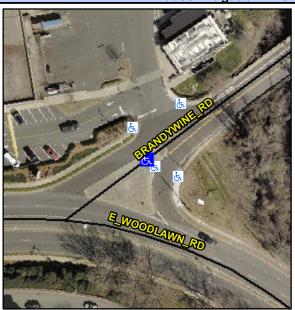
Field Measurements/Component Compliance							
Comp	liance Description	Data	Comp	liance Description	Data		
N/A	Ramp Length (in)	57.0	Yes	Ramp Slope (%)	6.3		
Yes	Ramp Width (in)	96.0	No	Ramp XSlope (%)	8.2		
N/A	Flare Type LT	N/A	N/A	Flare Type RT	N/A		
N/A	Flare Slope LT (%)	N/A	N/A	Flare Slope RT (%)	N/A		
N/A	Flare Traversable LT?	N/A	N/A	Flare Traversable RT?	N/A		
N/A	Landing Length (in)	N/A	N/A	DWS Provided?	N/A		
N/A	Landing Width (in)	N/A	N/A	DWS Contrast?	N/A		
N/A	Landing Slope (%)	N/A	N/A	DWS Length (in)	N/A		
N/A	Landing X Slope (%)	N/A	N/A	DWS Full Width?	N/A		
N/A	Landing Curb? (Y/N)	N/A	N/A	DWS Offset (in)	N/A		
N/A	Shared Landing?	N/A					
N/A	Gutter Ponding?	N/A	N/A	Gutter Slope (%)	N/A		
N/A	Gutter Lip Ht (in)	N/A	N/A	Gutter X Slope (%)	N/A		
N/A	Painted X Walk1?	No	N/A	Painted X Walk2?	N/A		
	X Walk 1 Direction	To N		X Walk 2 Direction	N/A		
N/A	X Walk 1 Width (in)	N/A	N/A	X Walk 2 Width (in)	N/A

X Walk 1 Slope (%)	1.9		X Walk 2 Slope (%)	N/A		
	X Walk 1 X Slope (%)	0.4		X Walk 2 X Slope (%)	N/A		
N/A	Ramp inside XWalk1?	N/A	N/A	Ramp inside XWalk2?	N/A		
	Road Slope (%)	N/A	N/A	Clear Space?	N/A		
	Road X Slope (%)	N/A	N/A	Clear Space to XWalk (in)	N/A		
N/A	Any Obstructions?	N/A	N/A	Storm Grate/Utility Hazard?	N/A		
	Obstruction Type			Storm Grate/Utility Type			
		N/A			N/A		
			Yes	Surface Condition? (G/P)	Good

COSIDIC COIGUION	
Possible Solutions:	Co
Remove & Replace Entire Ramp.	N/A
•	Ye
	N/A
	N/A
	N/A
	N/
Surveyor Notes:	N/
N/A	N/A
	N/A
	N/A
	N/
PROW/ADA:	N/
Not Found, R304.5.3	N/A
·	N/A
	N/A
	N/A

T. 10 1	•	40500
Total Cost:	\$	1650.0
