Access Compliance Report

Public Rights-of-Way

(Curb Ramps)

Intersection ID: 54325	Main Street: CANTERBURY CASTLE DR	Cross Street: ROCKY HILL CASTLE DR	Location: SW
ADA ID: B5A34D9AD3D3	Ramp Type: Perp	Initial Pass/Fail: Fail	Overall Compliance: No
Severity Score: 25			
Codes/Mitigation Info/Possible Solution		Field Measurements/Component Compliance

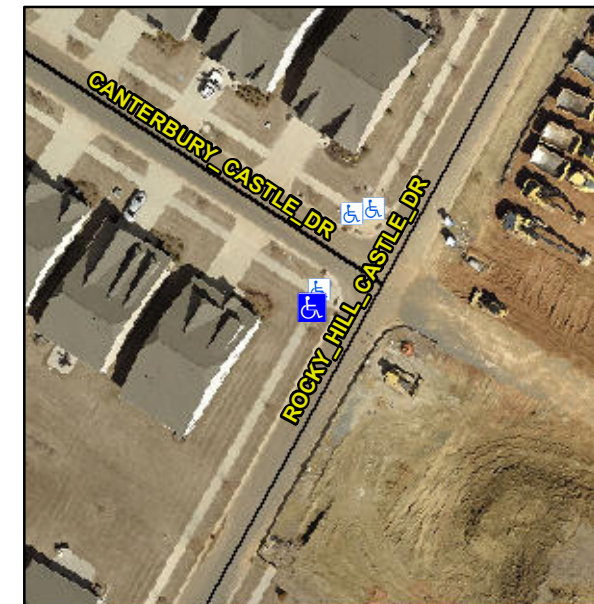
Compliance	Description	Data	Compliance	Description	Data
N/A	Ramp Length (in)	99.0	Yes	Ramp Slope (%)	6.0
Yes	Ramp Width (in)	48.0	No	Ramp XSlope (%)	9.5
N/A	Flare Type LT	N/A	N/A	Flare Type RT	N/A
N/A	Flare Slope LT (%)	N/A	N/A	Flare Slope RT (%)	N/A
N/A	Flare Traversable LT?	N/A	N/A	Flare Traversable RT?	N/A
N/A	Landing Length (in)	N/A	N/A	DWS Provided?	N/A
N/A	Landing Width (in)	N/A	N/A	DWS Contrast?	N/A
N/A	Landing Slope (%)	N/A	N/A	DWS Length (in)	N/A
N/A	Landing X Slope (%)	N/A	N/A	DWS Full Width?	N/A
N/A	Landing Curb? (Y/N)	N/A	N/A	DWS Offset (in)	N/A
N/A	Shared Landing?	N/A			
N/A	Gutter Ponding?	N/A	N/A	Gutter Slope (%)	N/A
N/A	Gutter Lip Ht (in)	1.0	N/A	Gutter X Slope (%)	N/A
N/A	Painted X Walk1?	No	N/A	Painted X Walk2?	N/A
	X Walk 1 Direction	To SE		X Walk 2 Direction	N/A
N/A	X Walk 1 Width (in)	N/A	N/A	X Walk 2 Width (in)	N/A
	X Walk 1 Slope (%)	1.3		X Walk 2 Slope (%)	N/A
	X Walk 1 X Slope (%)	4.5		X Walk 2 X Slope (%)	N/A

N/A	Ramp inside XWalk1?	N/A	N/A	Ramp inside XWalk2?	N/A
	Road Slope (%)	N/A	N/A	Clear Space?	N/A
	Road X Slope (%)	N/A	N/A	Clear Space to XWalk (in)	N/A
N/A	Any Obstructions?	N/A	N/A	Storm Grate/Utility Hazard?	N/A
	Obstruction Type			Storm Grate/Utility Type	
		N/A			N/A
		Yes		Surface Condition? (G/P)	Good

Possible Solutions:

Remove & Replace Entire Ramp.

PROW/ADA:

R304.5.3
